# Round Rock Stagecoach Inn

Round Rock, Texas

## Relocation Feasibility Study

December 5, 2016

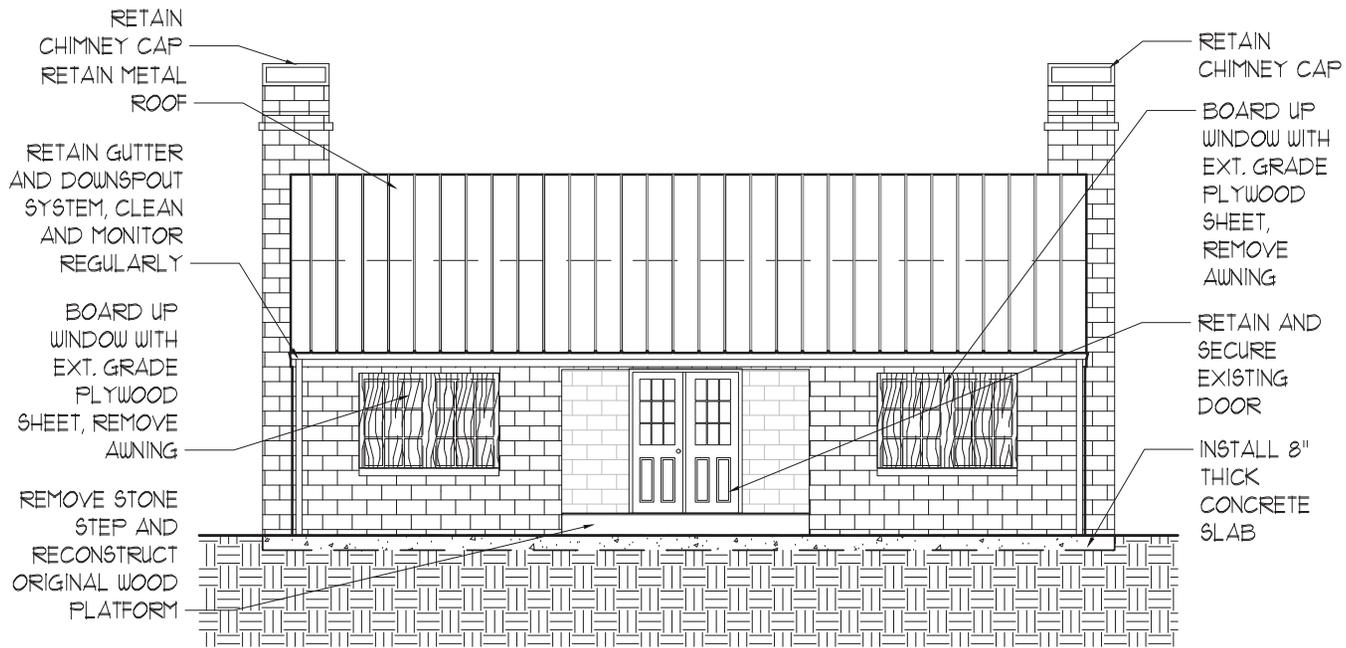
## Stabilization of Historic East Elevation

Figure 20. Elevations for Stabilization/Mothballing of East Elevation, after relocation to new site  
(Drawing by ARCHITEXAS, 2016)

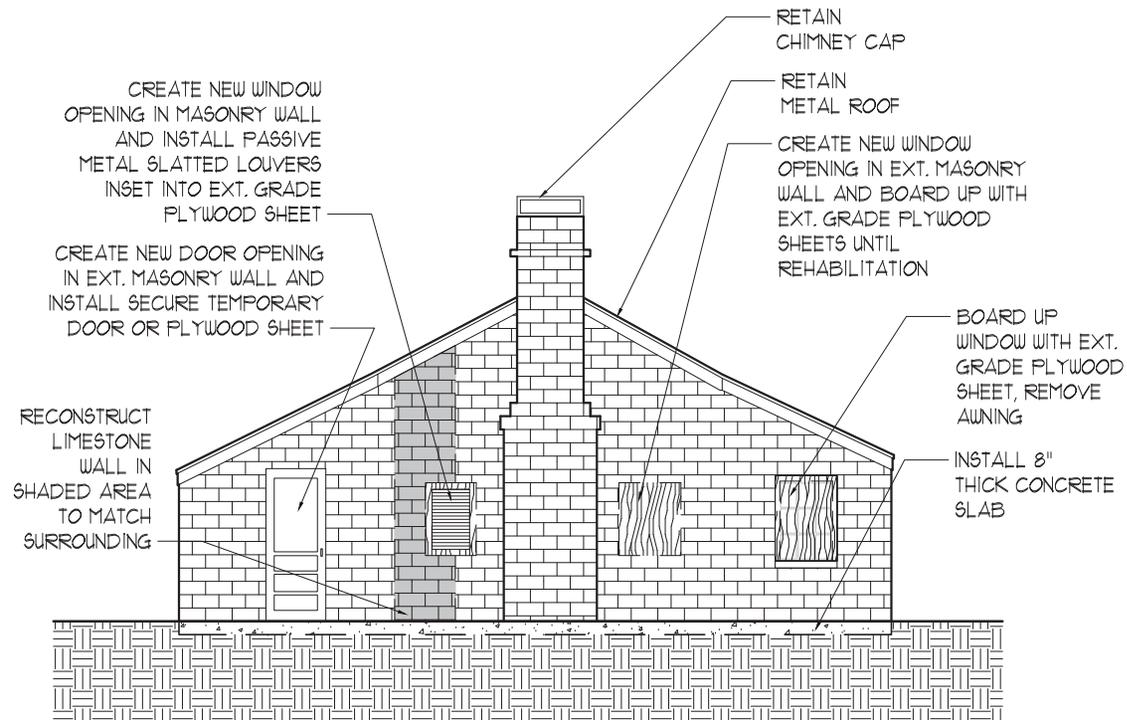
## Stabilization of Historic South Elevation

Figure 21. Elevations for Stabilization/Mothballing of South Elevation, after relocation to new site  
(Drawing by ARCHITEXAS, 2016)

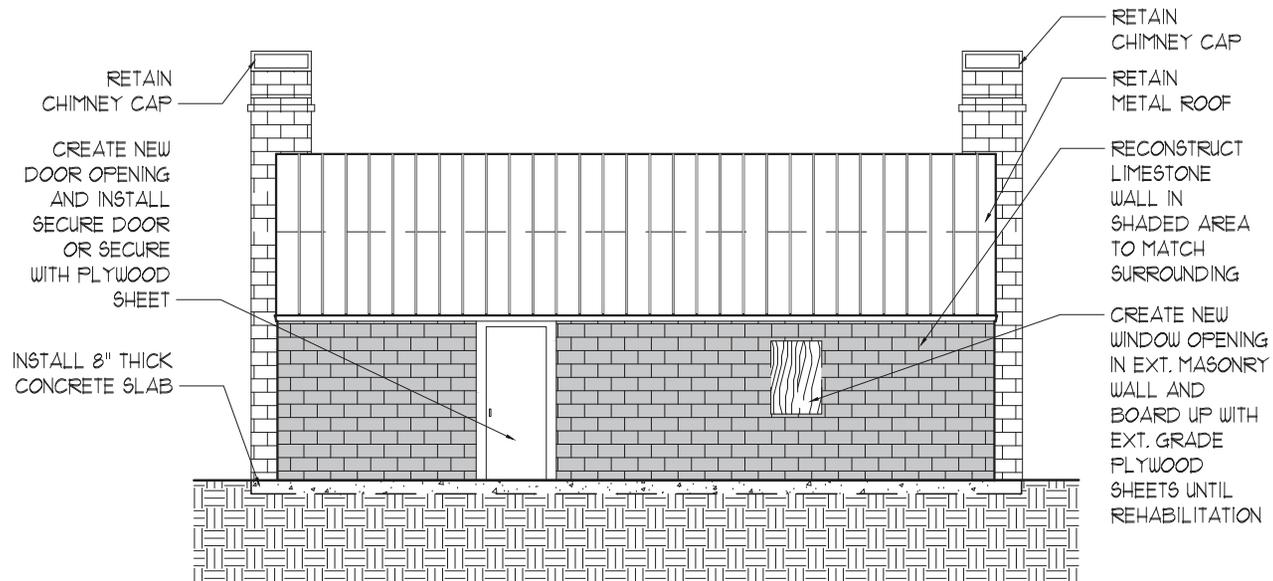
## Stabilization of Historic West Elevation

Figure 22. Elevations for Stabilization/Mothballing of West Elevation, after relocation to new site  
(Drawing by ARCHITEXAS, 2016)

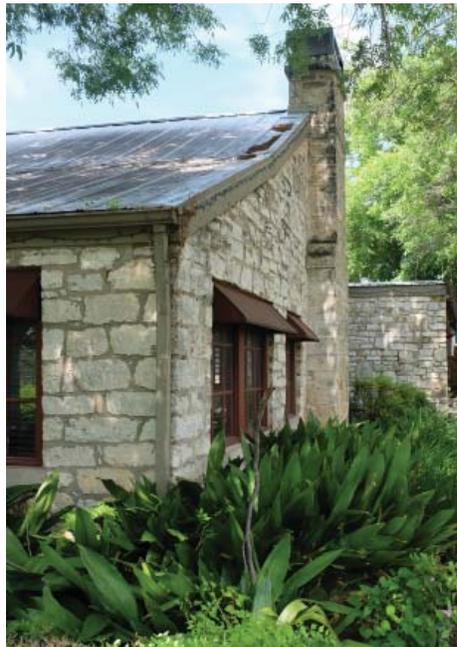
Painted gutters and downspouts at northeast corner

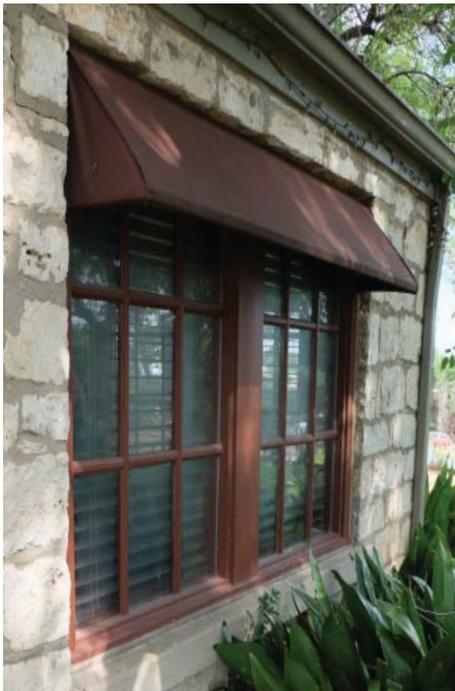
New double casement windows

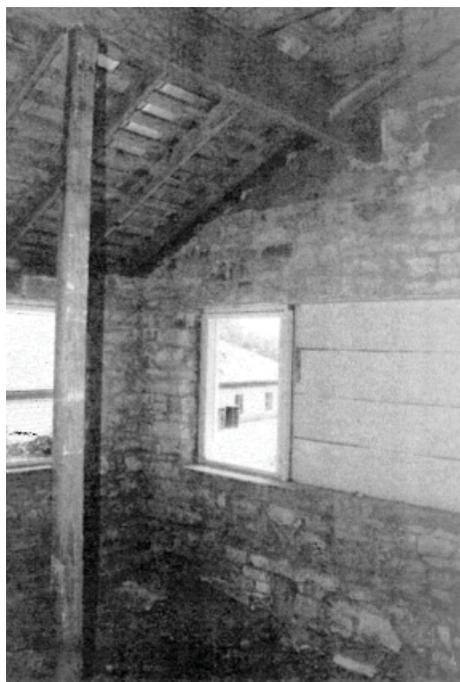
1990s Restoration showing roof construction  
(Source: City of Round Rock)

*The modern roof construction can be maintained during the move and after relocation. The building most likely originally had a pole and rafter roof construction. Historical documentation mentions beams made of hand-hewn oak. The historic roof construction is beyond the scope of this report and its reconstruction is depending on future programming needs and interpretation philosophies, as they are determined.*

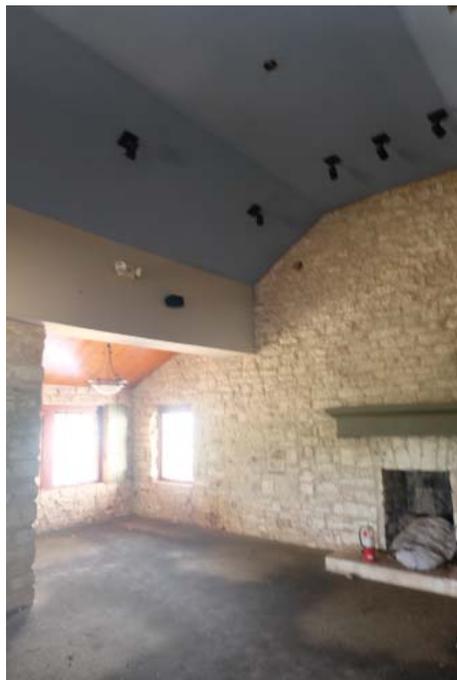
Interior carpet at south elevation

*During rehabilitation, cedar flooring should be installed throughout the interior.*
