## Structure notes – 103 W Liberty

## Summary:

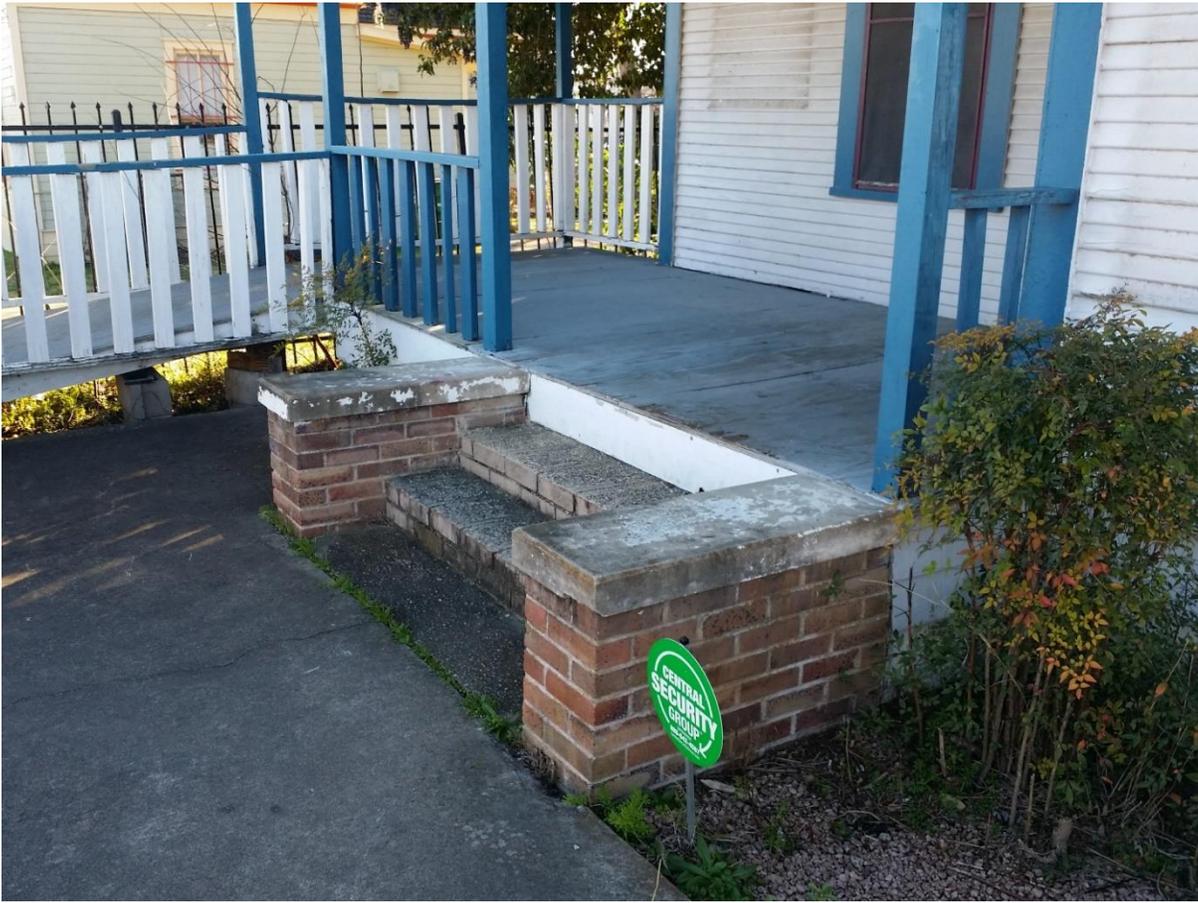
Front porch with ADA extension and plywood floor. Original brick wings by steps.

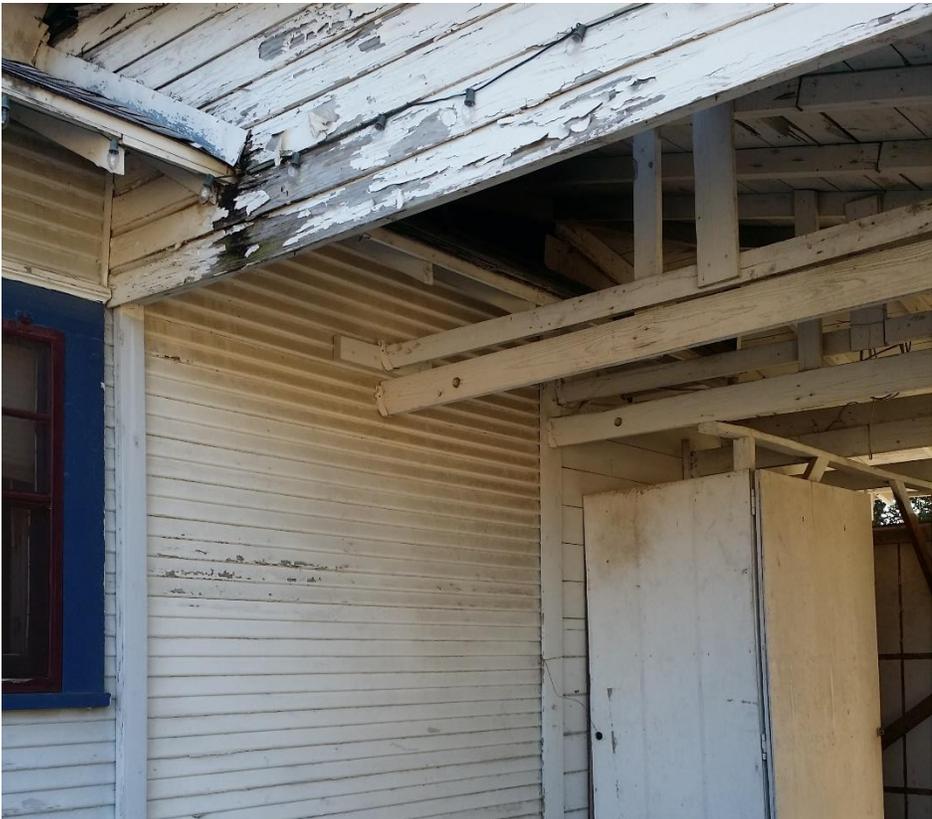
Carport has water damage. Original roof visible underneath. Addition starts where siding changes.

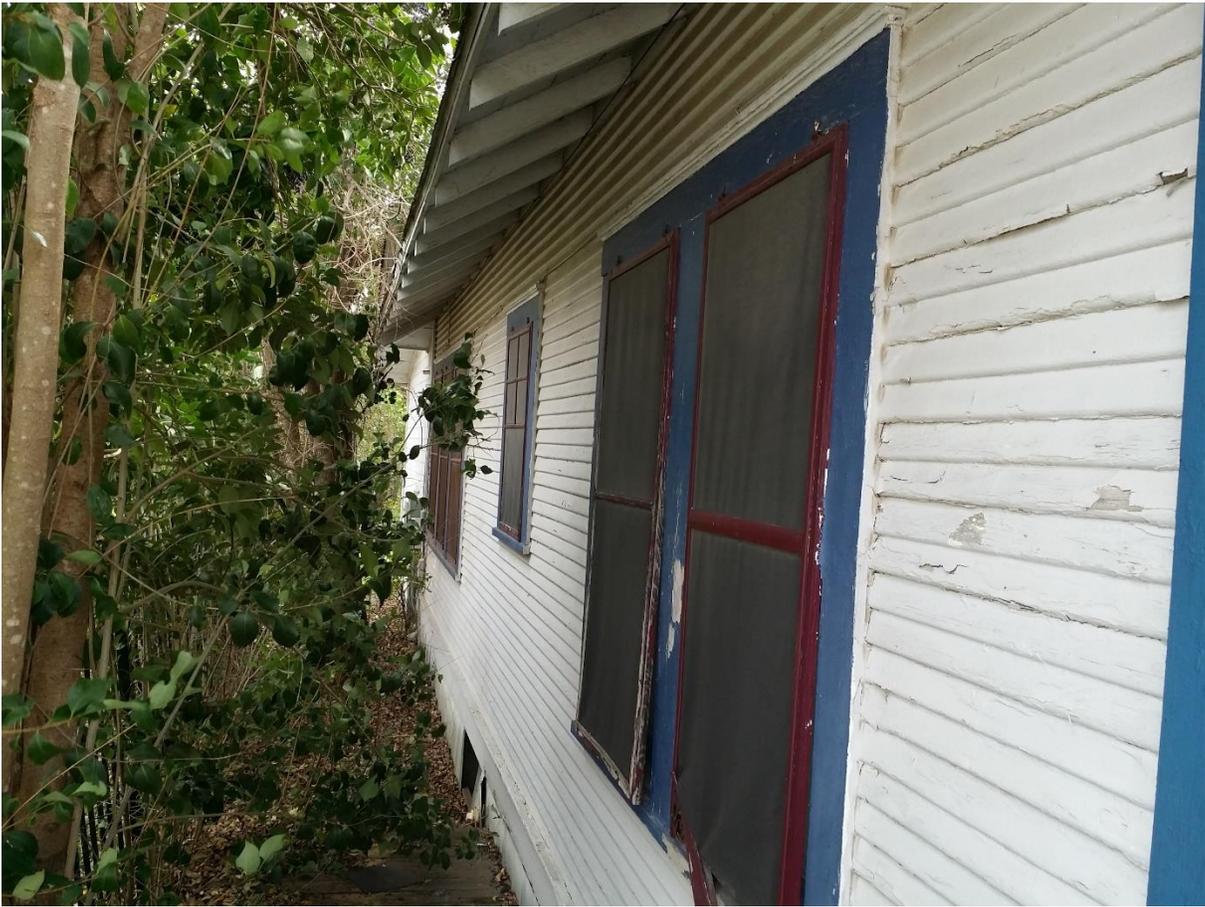
East side windows need repair.

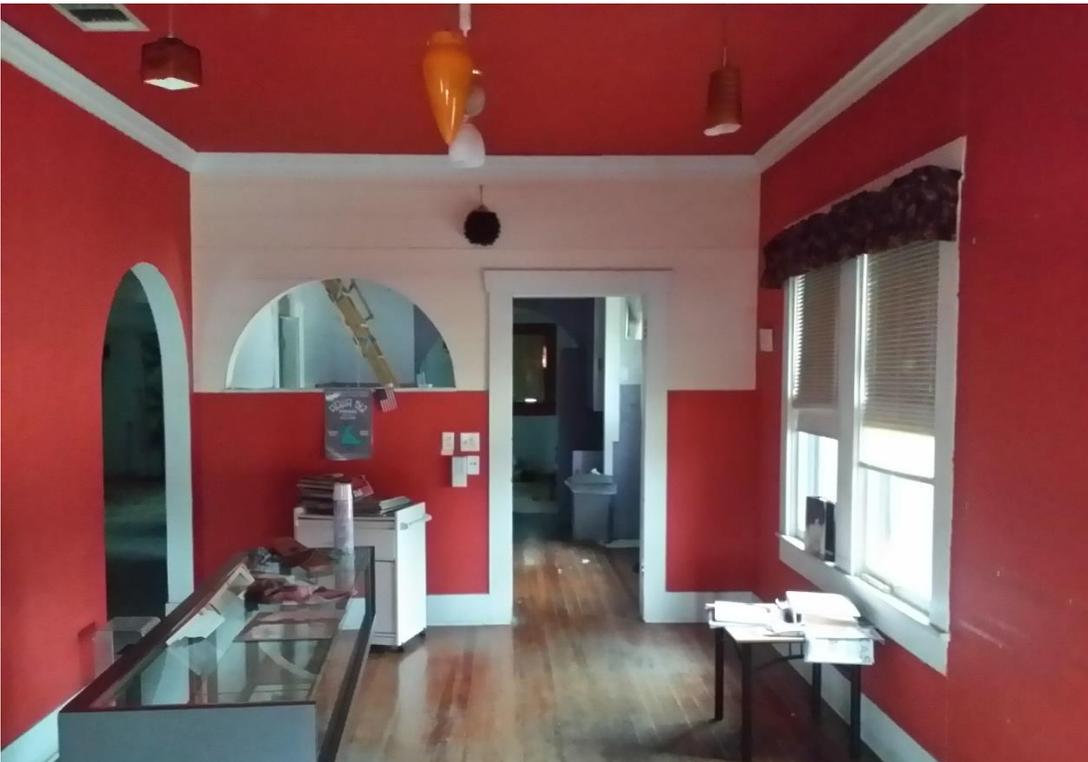
Wall between living and dining rooms has been altered
