City of Round Rock Parks and Recreation Department ADA Transition Plan (Adopted June 2018)

RE: Parks and Recreation Department ADA Transition Plan

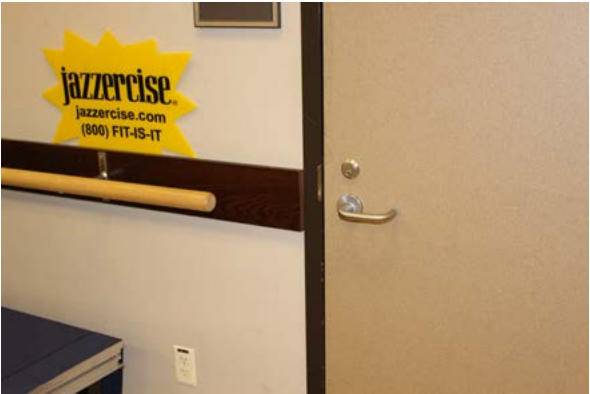
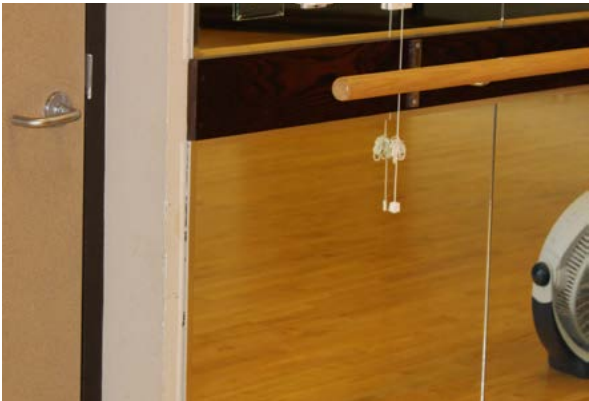
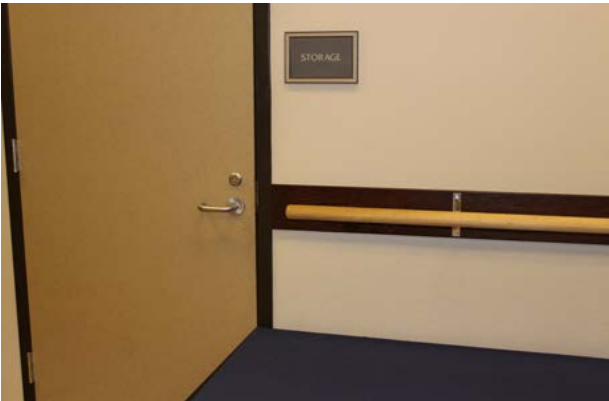
BACA-INT-1(a-b)

Aerobics Room

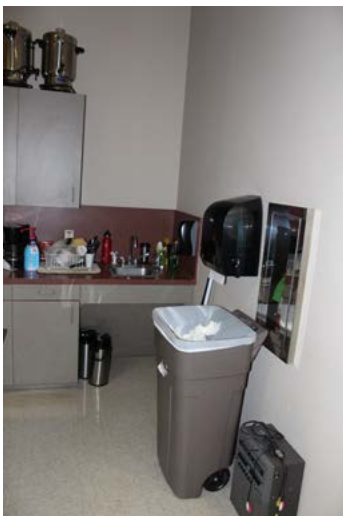
Break Room

- recess paper towel dispenser or replace with one less than 4" wide or permanently affix item below to prevent protrusion

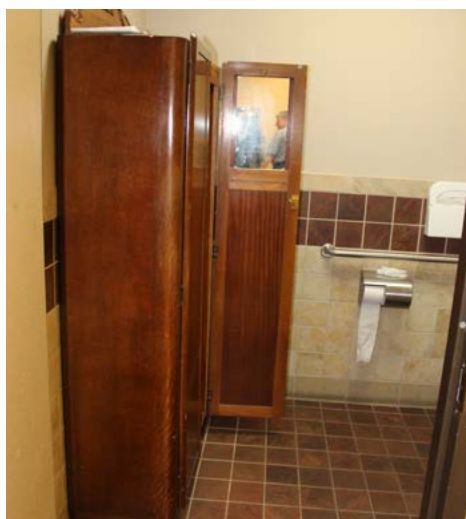
BACA-INT-2

Employee Restroom

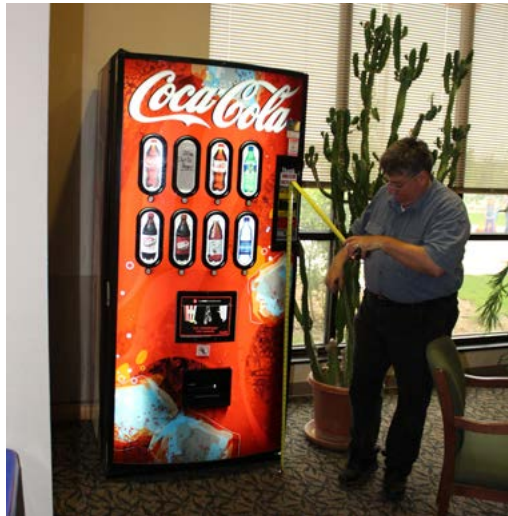
Vending Machine

- replace vending machine with compliant model

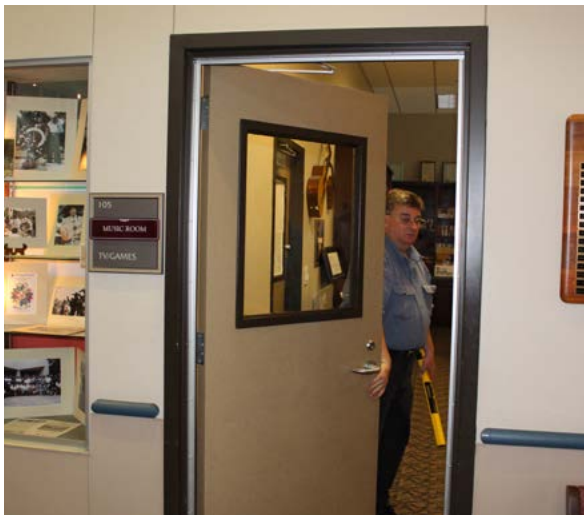
BACA-INT-4

Room Entries

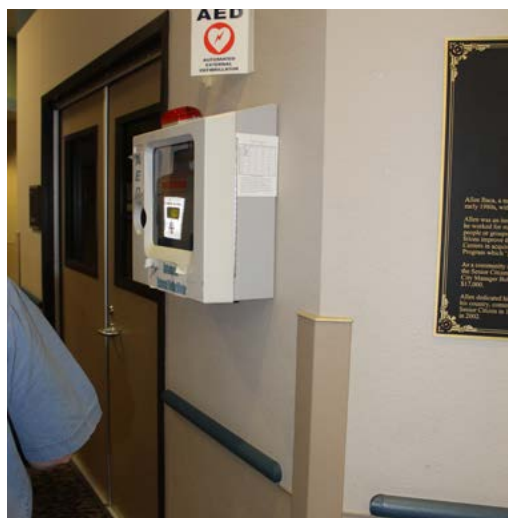
Main Lobby

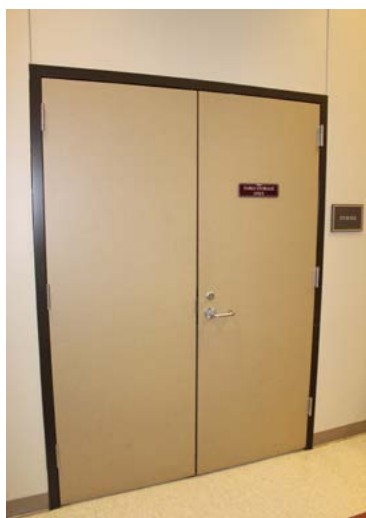
BACA-INT-6(a-b)

Grand Room

- replace doors with doors 32" wide

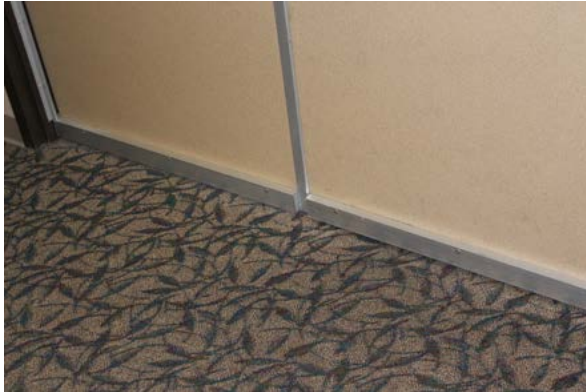
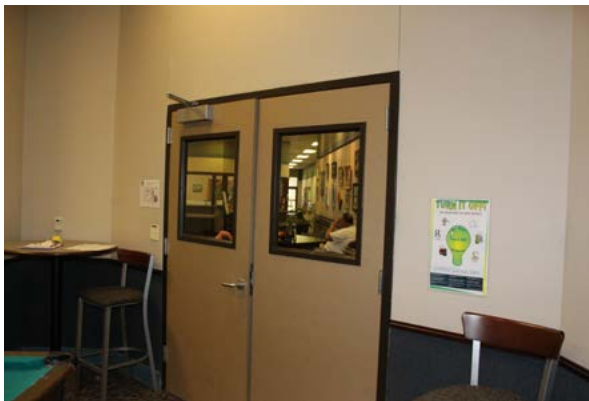
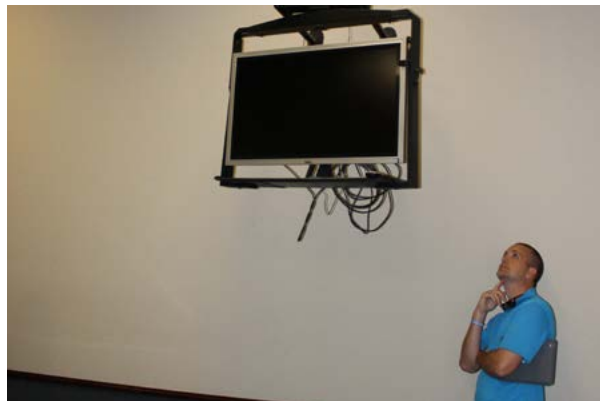
BACA-INT-8(a-c)

Billiards Room

- replace doors with compliant models
- raise TV above 80" and mount controller within reach ranges with appropriate CFS access

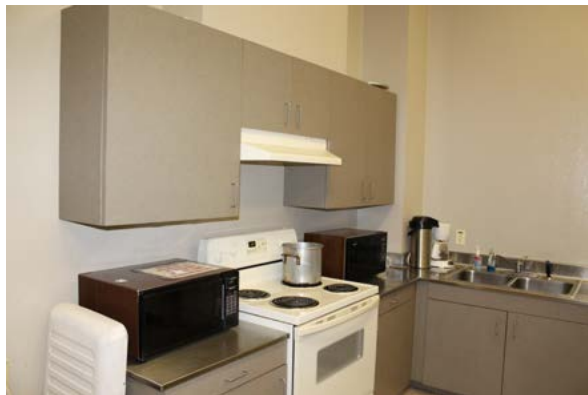
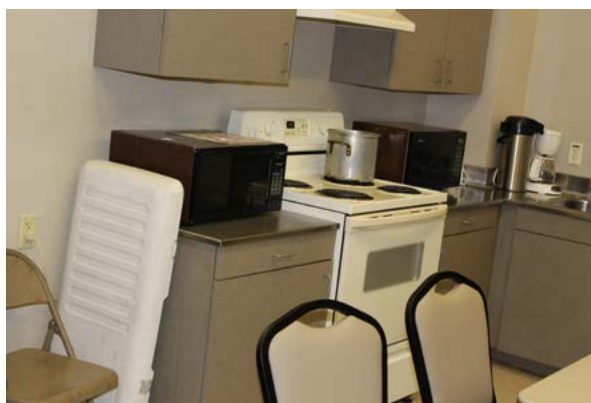
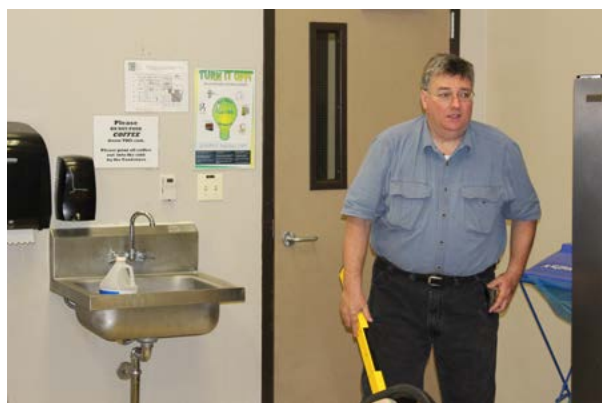
BACA-INT-10(a-e)

Warming Kitchen

- provide at least 50% storage within reach ranges
- replace appliance with accessible models and provide CFS
- insulate utility sink pipes
- relocate utility sink 18" from latch side of door

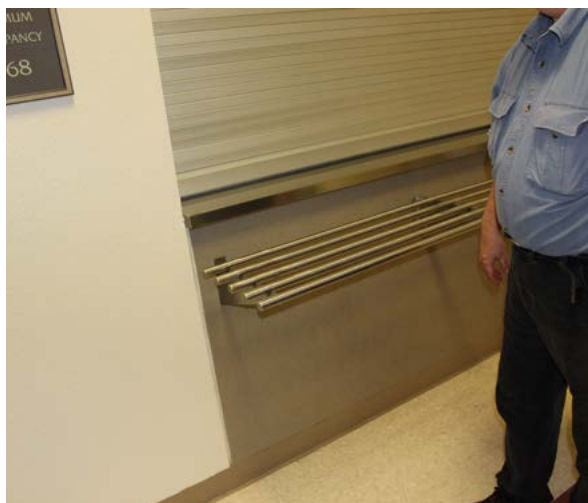
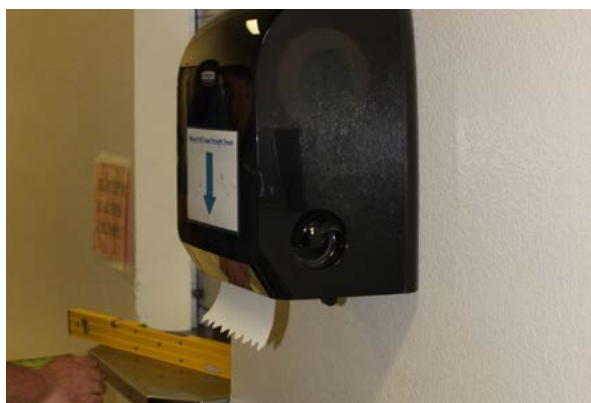
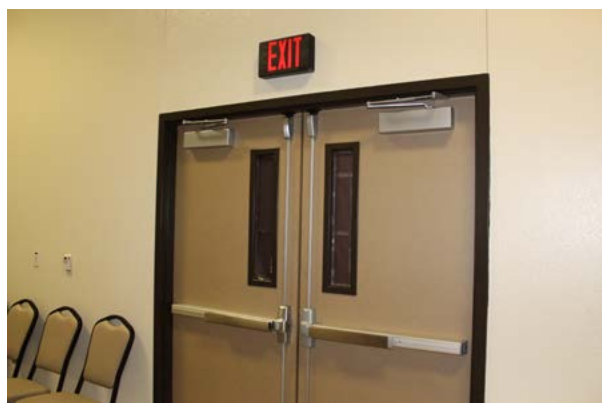
BACA-INT-11(a-d)

Cafeteria

- a. verify proper circulation routes in kitchen (804.2)
- b. verify tray slides comply (904.5.2)
- c. paper towel dispenser is a protruding object (307.2)
- d. exit door is missing tactile sign (216.4.1)

- verify regulations are being met
- recess paper towel dispenser or replace with one less than 4" wide or permanently affix item below to prevent protrusion
- d. add compliant tactile sign at all exit doors

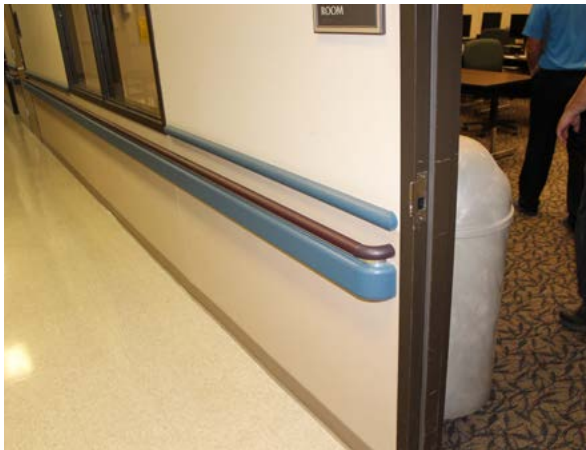
Hallways

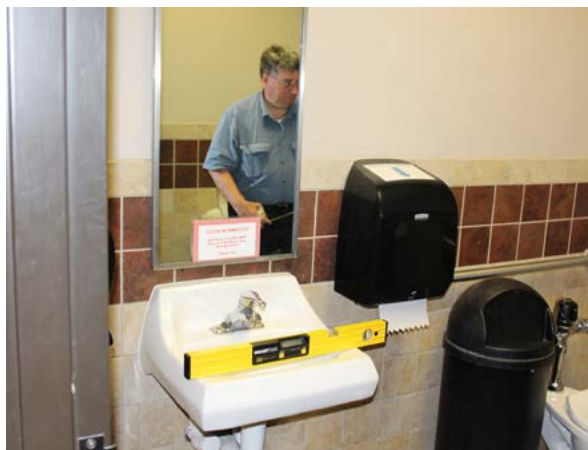
Family Restroom near Grand Room

- recess paper towel dispenser or replace with one less than 4" wide or permanently affix item below to prevent protrusion

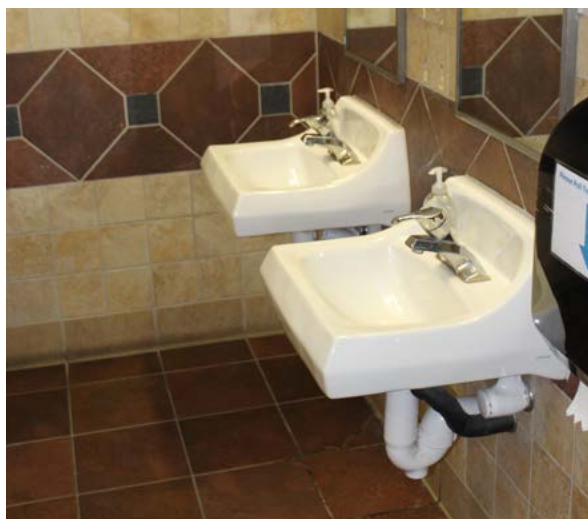
BACA-INT-15

Women's Restroom near Main Office

- recess paper towel dispenser or replace with one less than 4" wide or permanently affix item below to prevent protrusion
- raise sinks to provide proper knee clearance

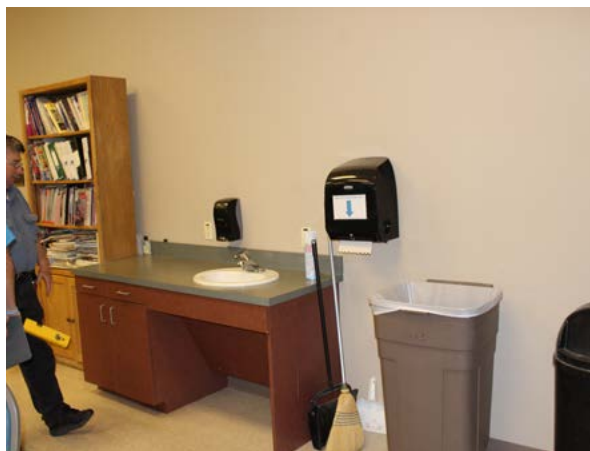
Art Room

- recess paper towel dispenser or replace with one less than 4" wide or permanently affix item below to prevent protrusion
- add additional storage and outlets within reach range
- insulate exposed pipes

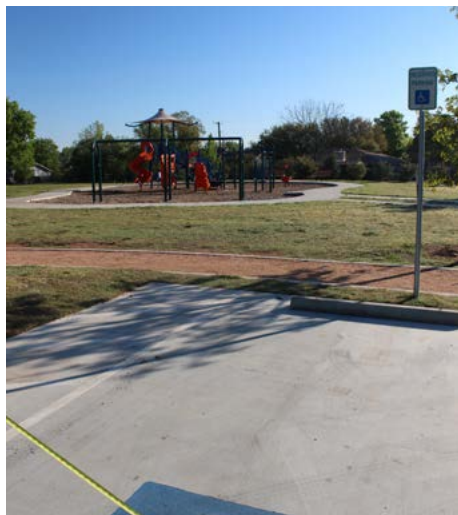
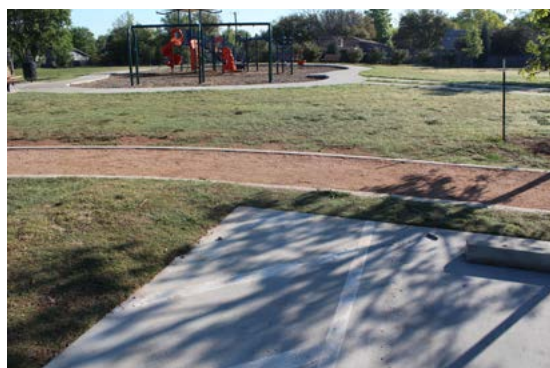
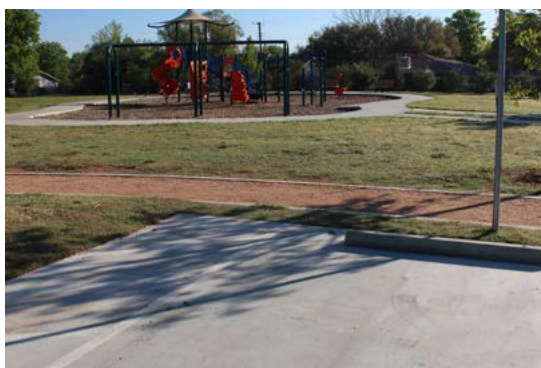
BOWM-EXT-1(a-c)

Parking Lot and Access

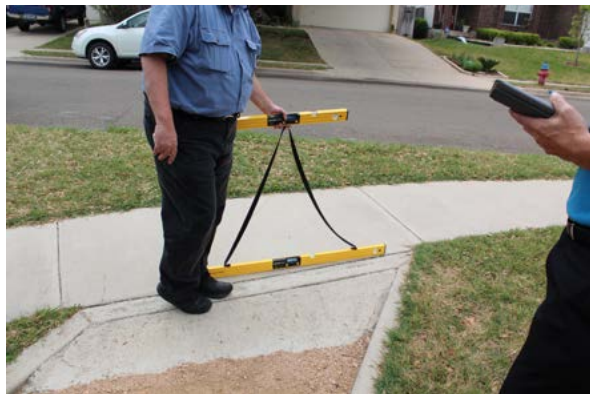
Trail entrance from sidewalk at street

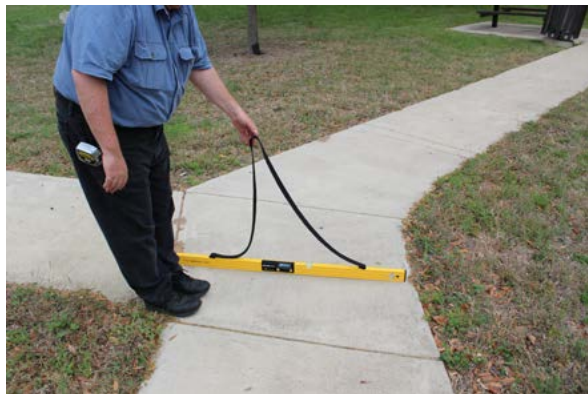
Y-intersection at picnic areas

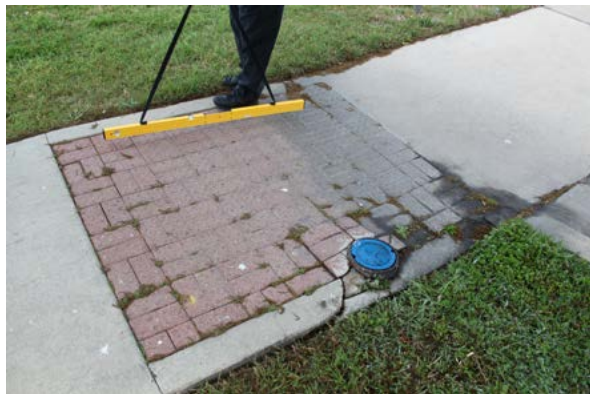
CMRC-EXT-2(a-c)

CMRC Western Parking Lot Access Route

- regrade and replace section of ramp/surrounding accessible route to provide accessible slopes
- regrade surrounding area to ensure proper drainage, thus keeping ramp free from debris

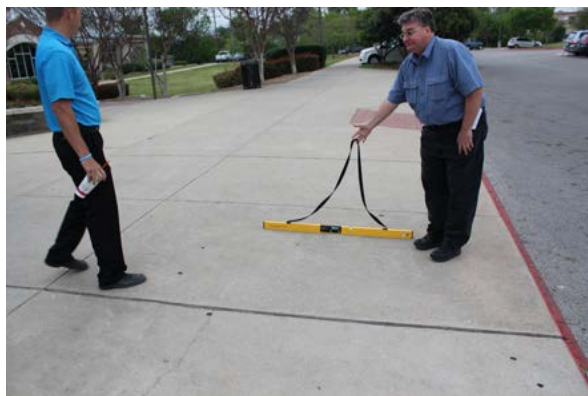
CMRC-EXT-4(a-d)

CMRC dropoff / main entry plaza

- level to ensure proper slopes
- replace ramp / surrounding area to ensure proper slopes
- relocate trash can to level location to ensure CFS
- fill gaps in accessible walk

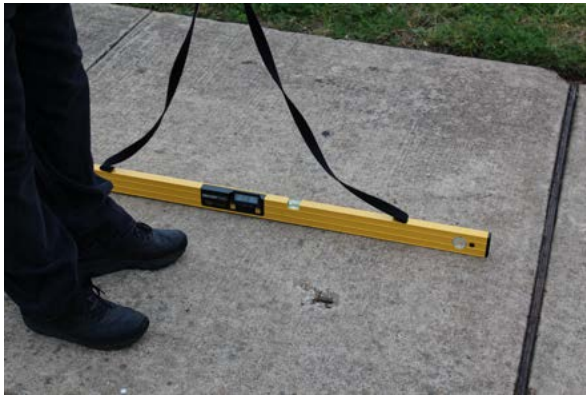
CMRC-EXT-5(a-d)

CMRC Tennis Courts

- replace ramp / surrounding area to ensure proper slopes
- lower fence latch
- replace fountain with two bowl compliant model
- fill all gaps in accessible walk

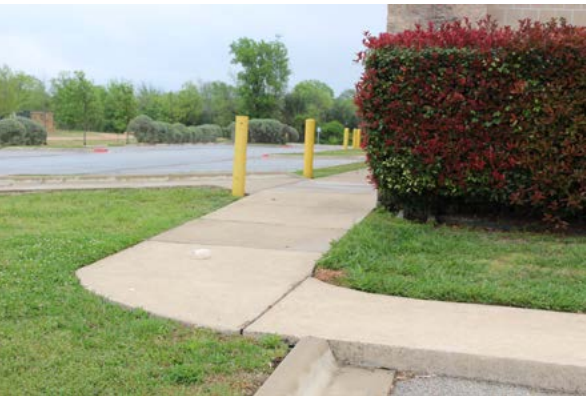
CMRC Route Egress at Rear of Building

- replace and regrade surrounding area to ensure proper running slope

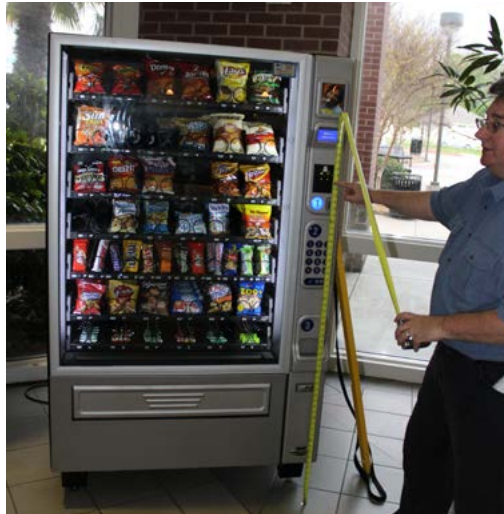
CMRC-INT-1(a-b)

CMRC Main Lobby

- replace with vending machines with all operating parts within reach range (work with vendor)

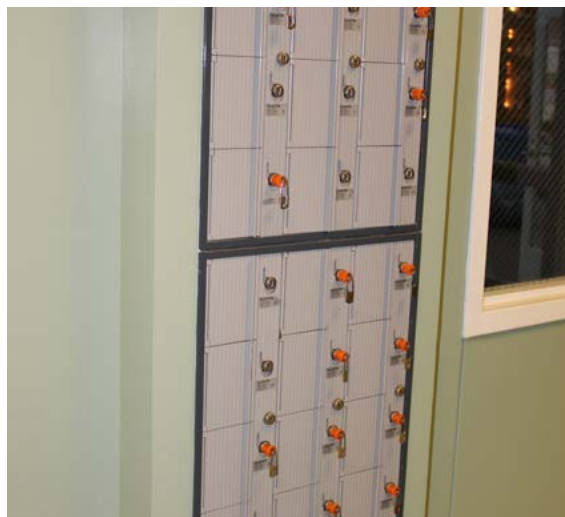
CMRC weightroom/locker room hallway

- Replace lockers and/or handles to non-twisting lever
- lower job clock to within reach range
- recess AED so it doesn't protrude more than 4" or permanently affix item below to prevent protrusion
- Lower AED mount
- replace change machine with one with proper reach range

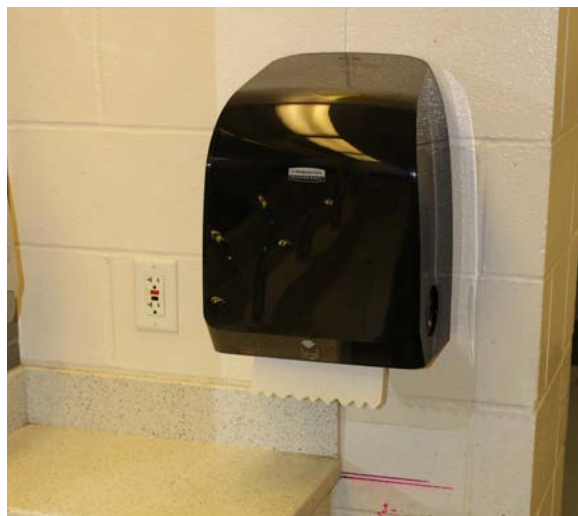
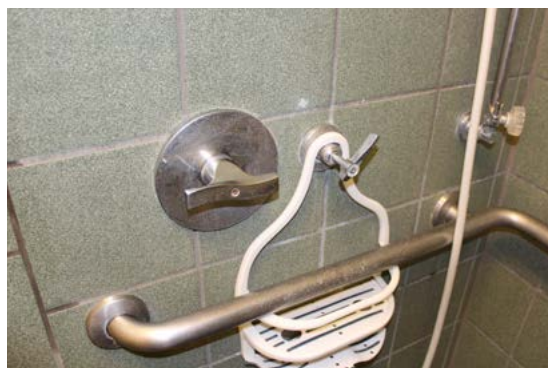
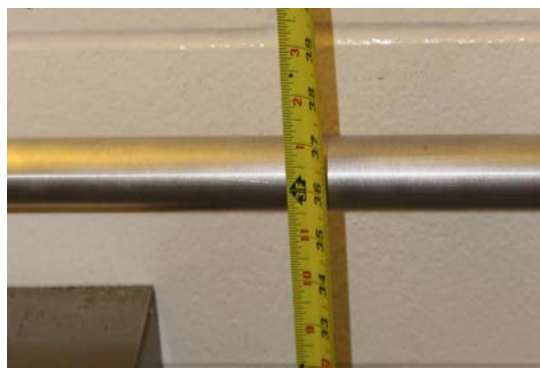
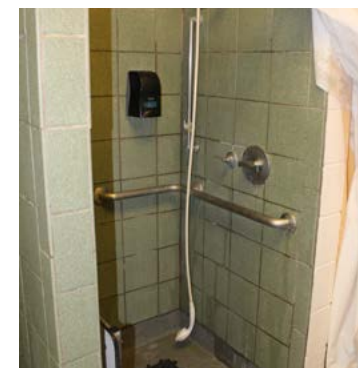
CMRC-INT-6(a-i)

CMRC Locker Rooms

- add accessible bench in shower stall and replace shower head with one that has an on/off switch and has a fixed/
- add hooks where necessary
- add signage that fan operation is by employees only
- recess paper towel dispenser or replace with one less than 4" wide or permanently affix item below to prevent protrusion

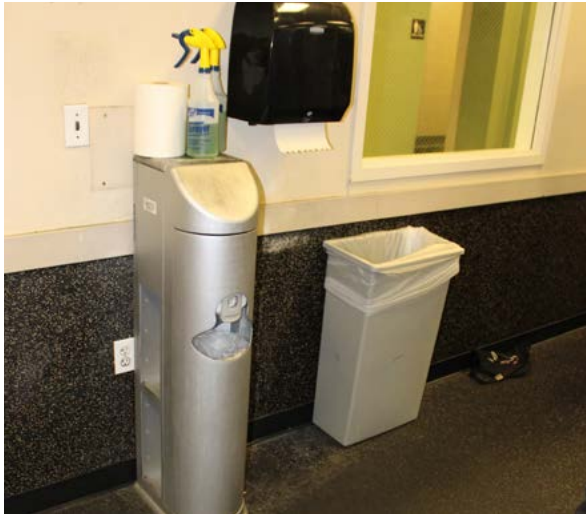
CMRC Weight Room

- lower switches and thermostat controls
- rearrange machines to provide CFS
- recess paper towel dispenser or replace with one less than 4" wide or permanently affix item below to prevent protrusion

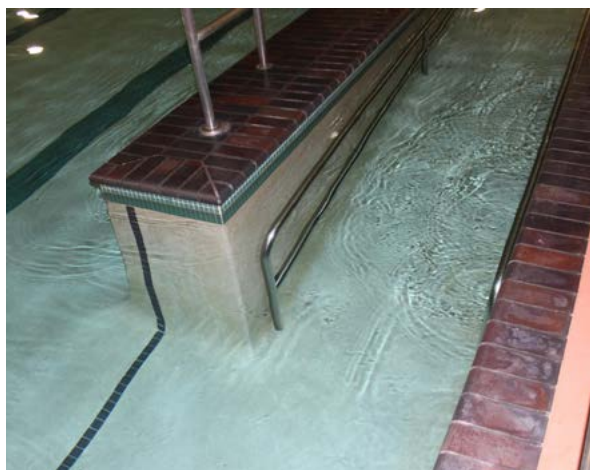
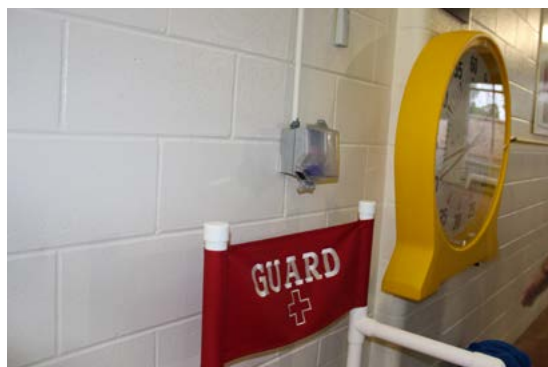
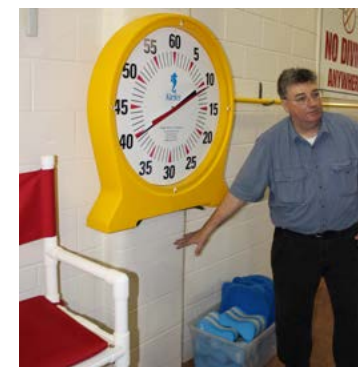
CMRC-INT-9(a-e)

CMRC Pool

- modify handrail to extend past ramp
- replace with clock that is less than 4" wide or permanently affix item to floor below to prevent protrusion
- lower at least one hook
- permanently affix item below to prevent protrusion
- label storage room as "Employee Only" space

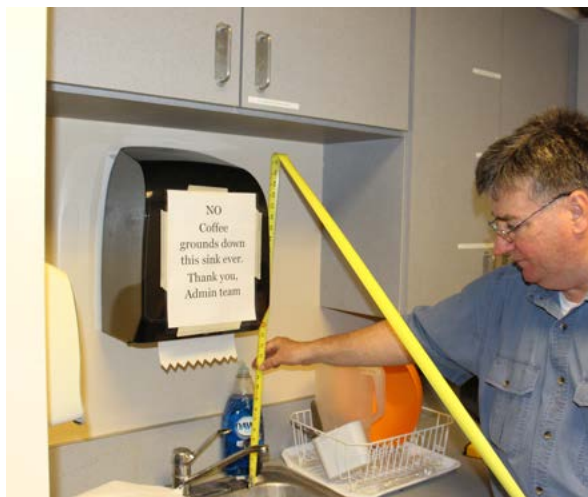
CMRC Administration Offices

- replace fire alarm with one with a strobe light
- relocated or lower paper towel dispenser (no action necessary as this is an Employee Only space)

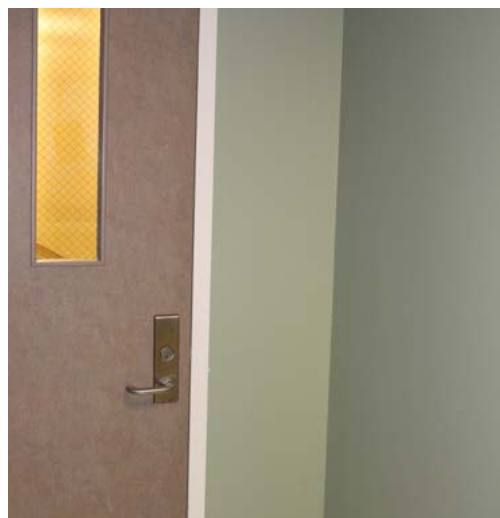
CMRC-INT-10(a-b)

CMRC Meeting Room hallway

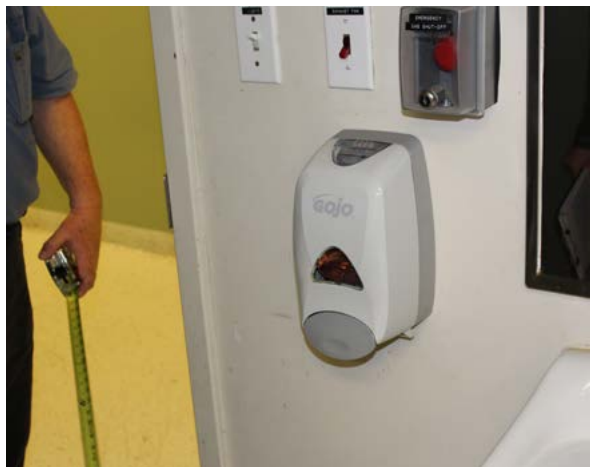
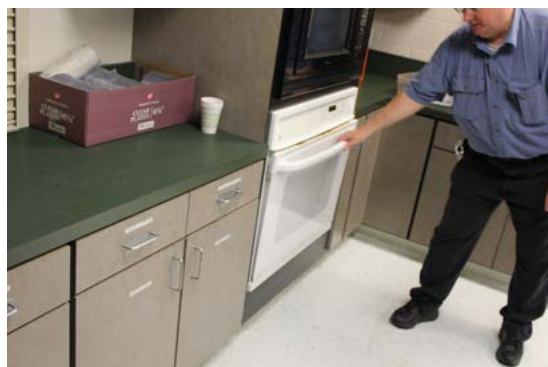
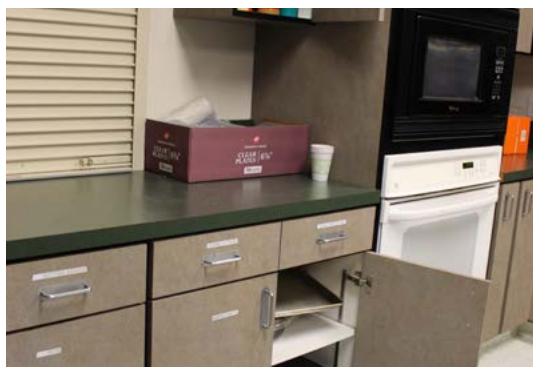
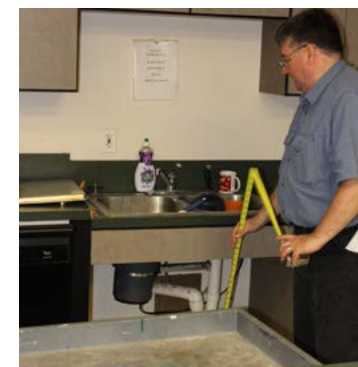
CMRC-INT-12(a-h)

CMRC Kitchen

- rearrange kitchen to provide CFS needed at oven
- ensure 50% of storage shelves are within reach ranges (entirely above 15" and entirely below 48")
- lower sink to below 34" to the highest rim/counter
- replace stove with compliant model
- lower outlets to within reach range
- recess paper towel dispenser or replace with one less than 4" wide or permanently affix item below to prevent protrusion

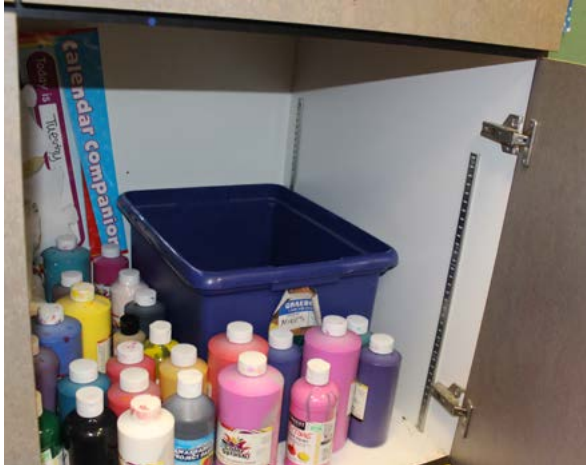
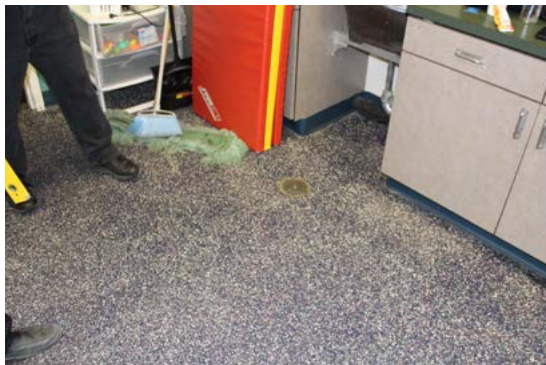
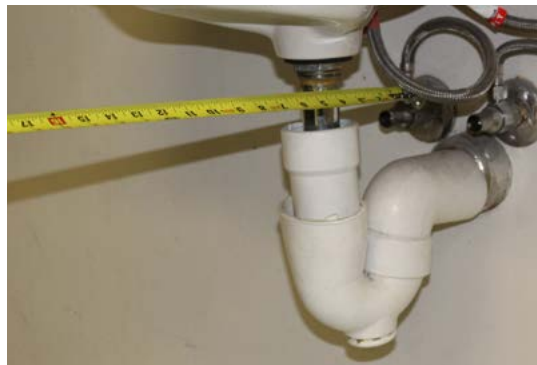
CMRC-INT-13(a-c)

CMRC Art Room

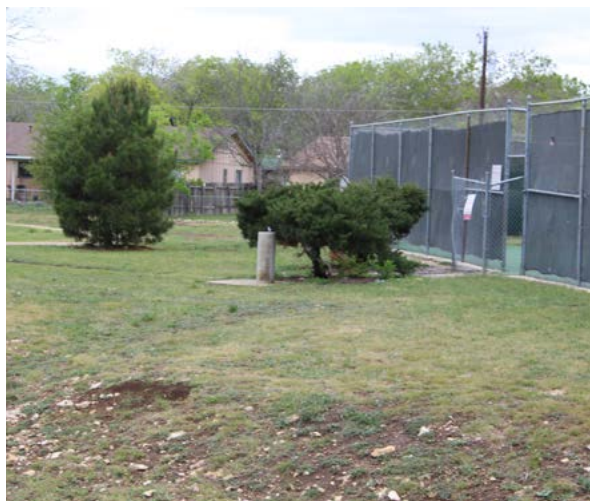
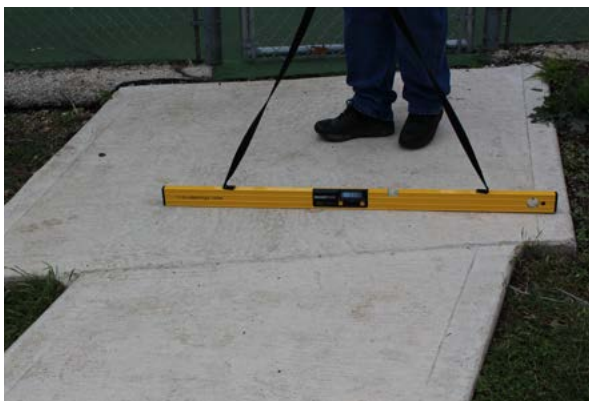
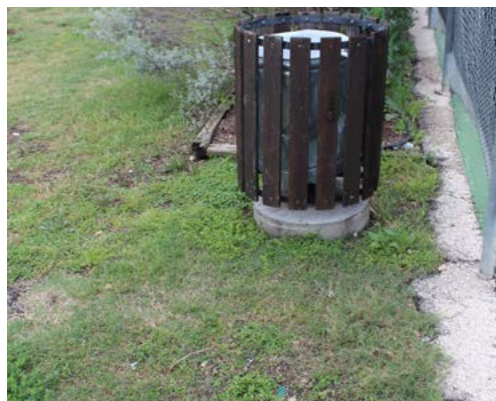
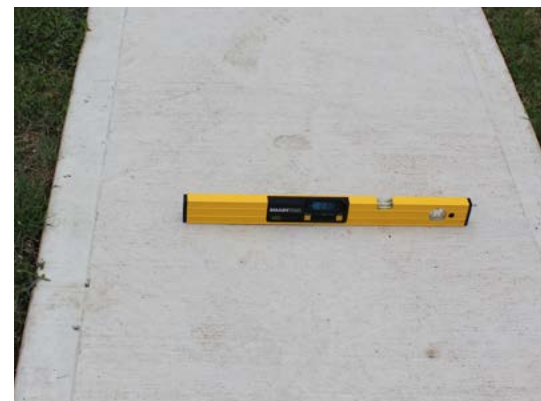
FRNT-EXT-1(a-d)

Tennis Court

- realign and make entry at tennis larger
- install garbage can along accessible route with proper CFS
- replace and regrade surrounding area to ensure proper slopes along accessible route
- provide accessible route to drinking fountain or remove if no longer functional

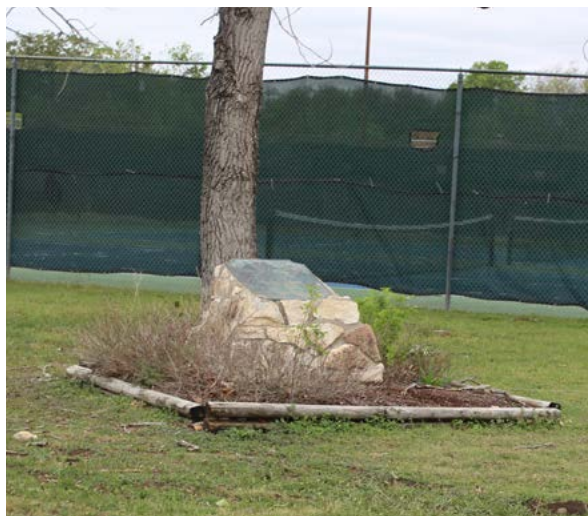
Donor Plaque

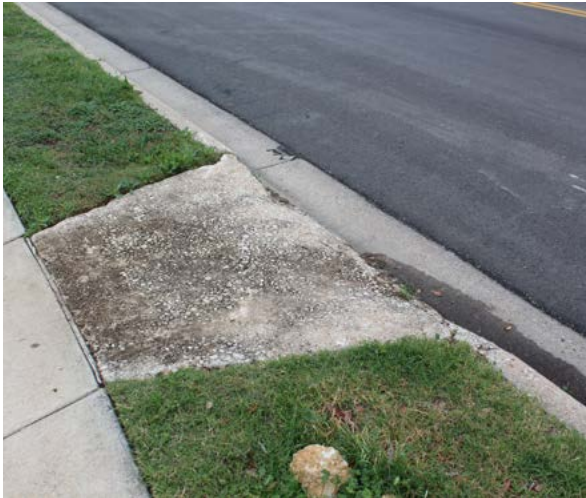
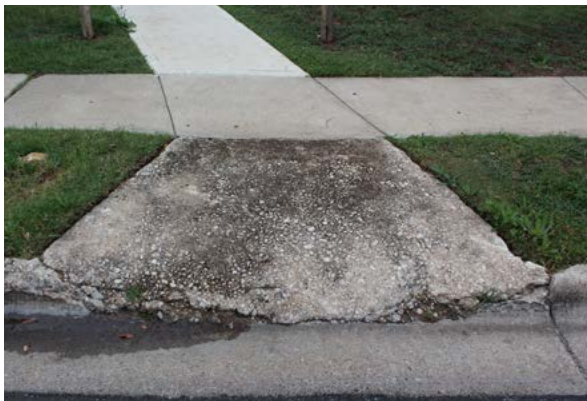
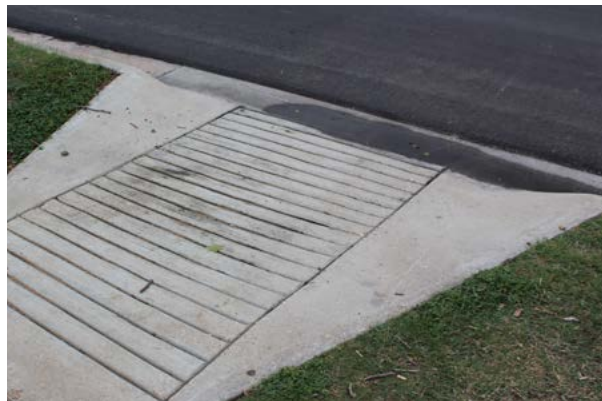
FRNT-EXT-4(a-b)

Curb Ramps

- remove and replace entry ramps with proper slopes and domes in the ROW

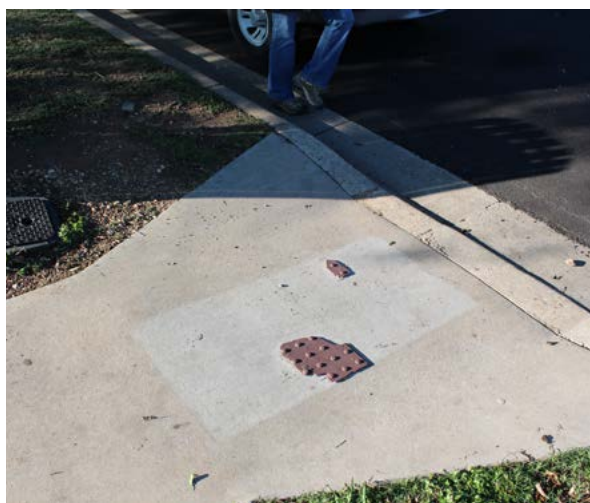
Barrier Location:

Curb Ramps

Recommendation:

- remove and replace entry ramps with proper slopes and domes in the ROW
- replace and regrade surrounding area to ensure proper slopes

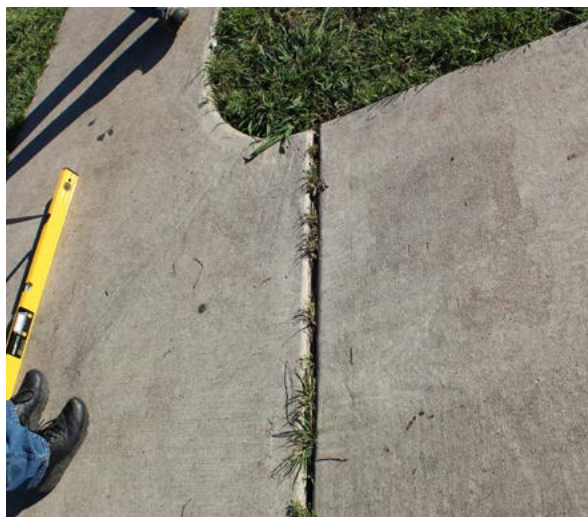
GREN-EXT-2

**Barrier Location:**

Wood Joints

Recommendation:

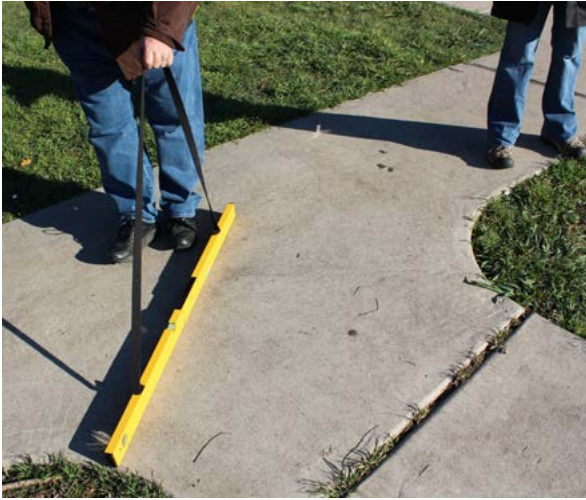
Barrier Location:
Accessible Route

Recommendation:

- remove and replace entry ramps with proper slopes and domes in the ROW
- replace and regrade surrounding area to ensure proper slopes

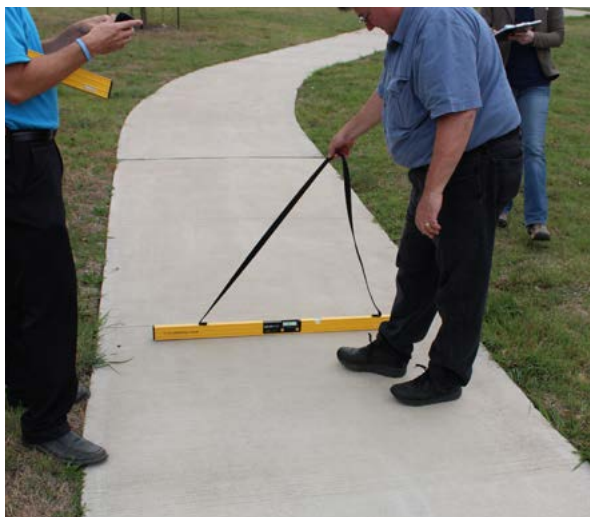
Barrier Location:

Trail near and around entrance to playground

Recommendation:

- regrade and replace surrounding area to ensure proper cross slope

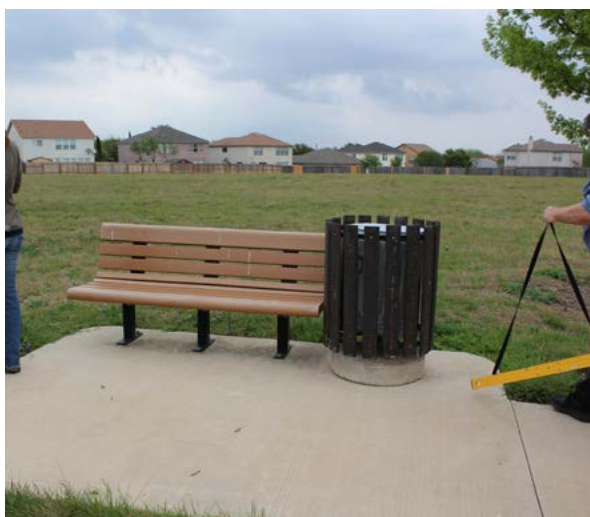
Barrier Location:

Bench Area

Recommendation:

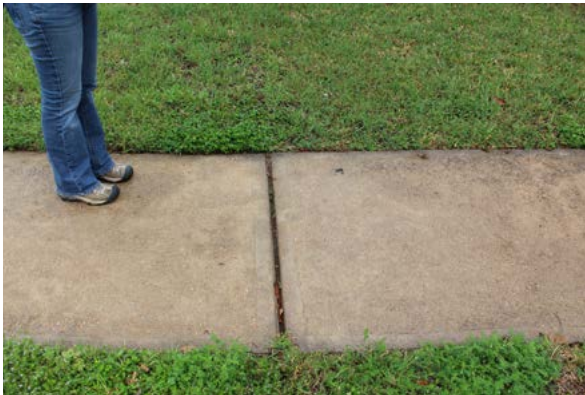
KINN-EXT-1

**Barrier Location:**

Accessible Routes

Recommendation:

- replace and regrade surrounding area to ensure proper running slope
- repair all areas of sidewalks missing chunks of pavement

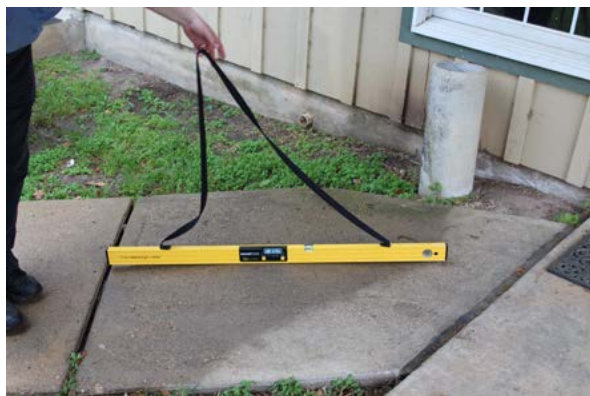
**Barrier Location:**

Kinningham Entrance to House from Garage

Recommendation:

- replace and regrade surrounding area to ensure running slope does not exceed 5% or convert to ramp and regrade to meet 8.3% slope and install handrails
- decrease threshold to be 1/2" maximum

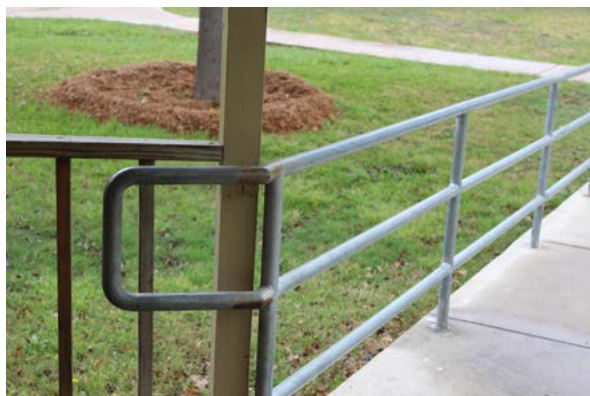
**Barrier Location:**

Kinningham House Ramp and Deck

Recommendation:

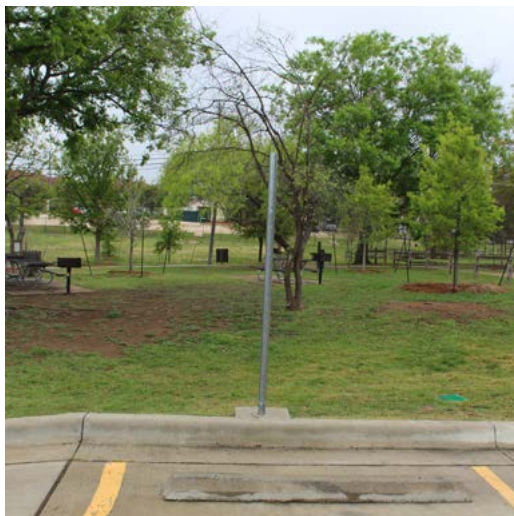
Barrier Location:

Kinningham Parking Lot

Recommendation:

- replace sign
- level ADA parking space to less than 2% in all directions
- replace and regrade surrounding area to ensure cross slope does not exceed 2%

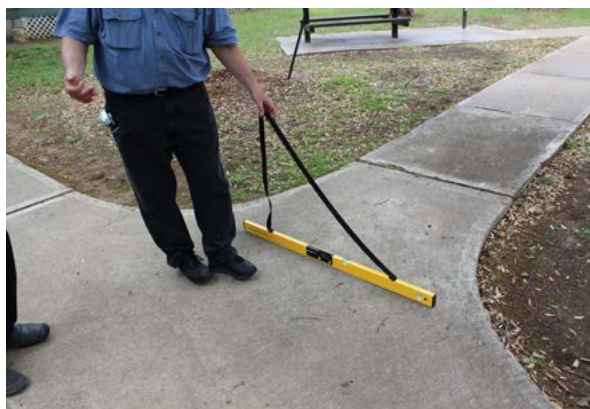
Barrier Location:

Accessible route at Drinking Fountain

Recommendation:

- replace and regrade surrounding area to provide CFS at drinking fountain and proper slopes on surrounding accessible routes

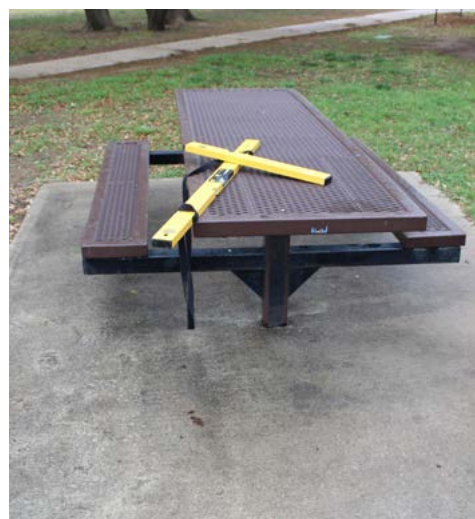
KINN-EXT-6(a-b)

Barrier Location:

ADA picnic table

Recommendation:

- replace table with compliant model

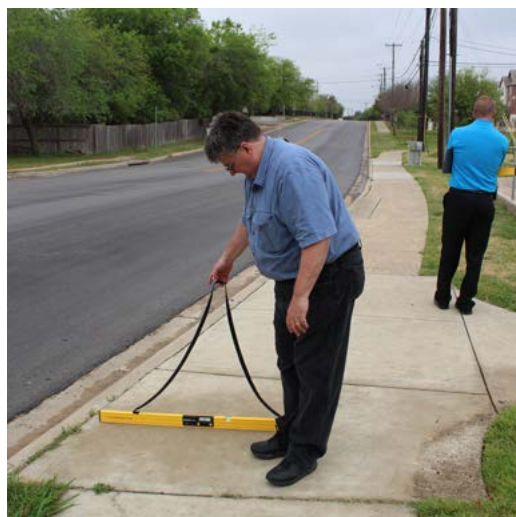
Barrier Location:

Accessible Route from street

Recommendation:

- replace and regrade surrounding area to ensure cross slope does not exceed 2% and running slope does not exceed 5%

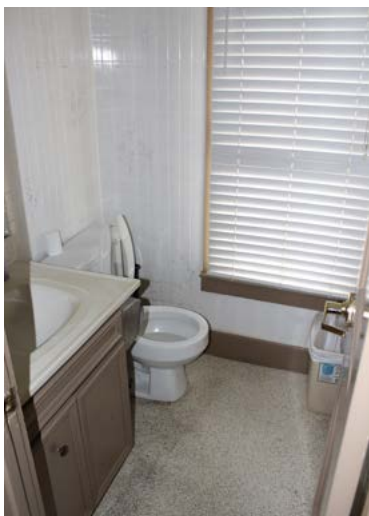
**Barrier Location:**

Kinningham Restroom off Kitchen

Recommendation:

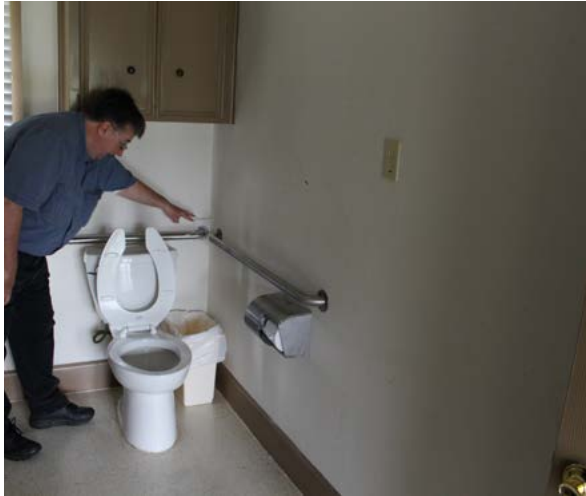
Barrier Location:

Kinningham Back Restroom

Recommendation:

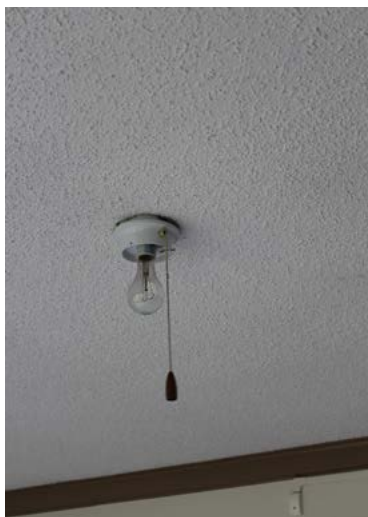
Kinningham Outside Back Restroom

Barrier Location:

Recommendation:

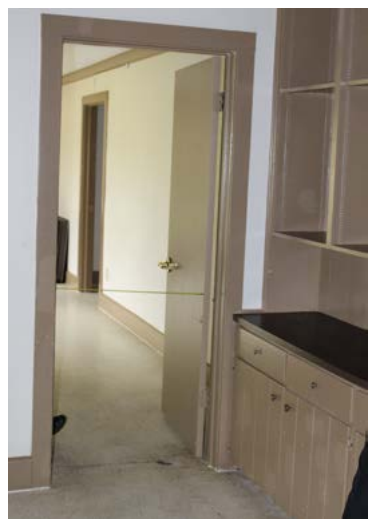
KINN-INT-5

Back Restroom Hall/Storage Area

Recommendation:

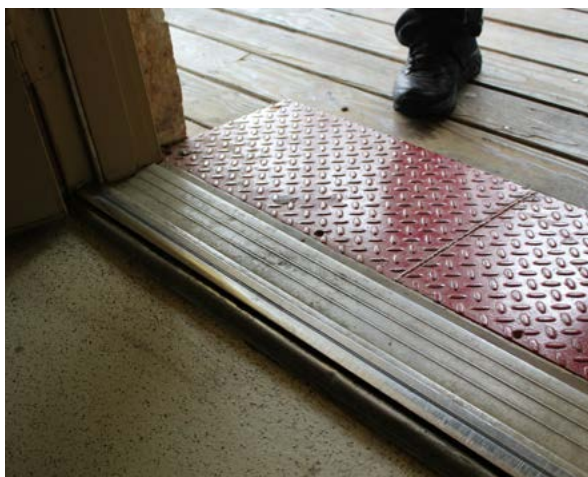
Kinningham Doorway to deck

Recommendation:

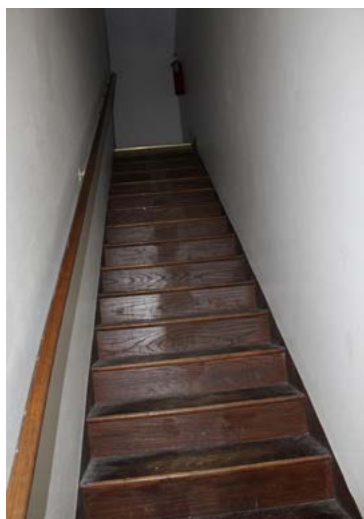
KINN-INT-7

Kinningham Upstairs

Recommendation:

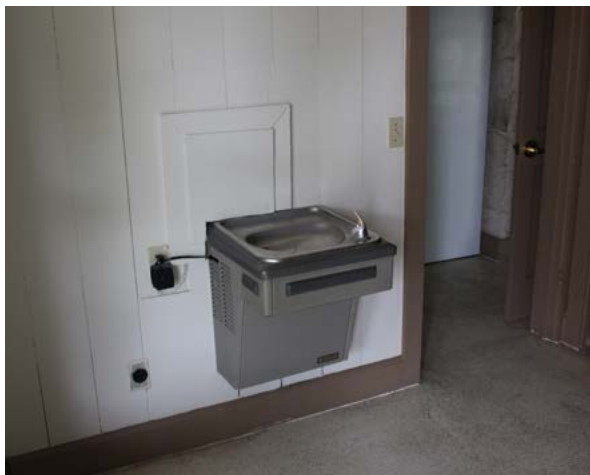
Kinningham Drinking Fountain

Recommendation:

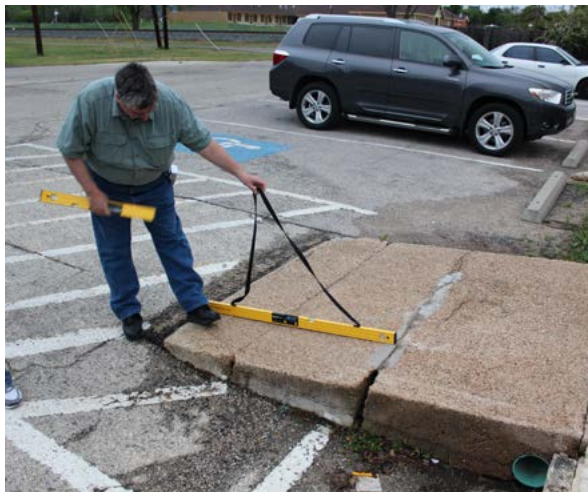
Pool Parking Lot

- replace and regrade surrounding area to ensure proper slopes

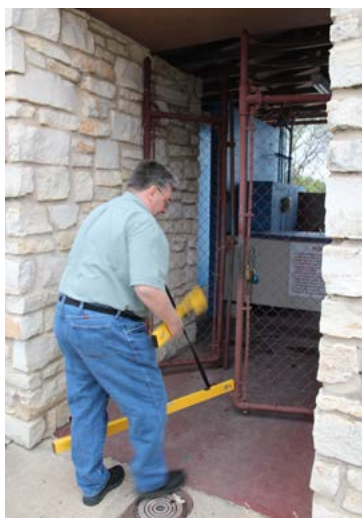
LAKE-EXT-1

Pool Entry Gate

- widen gates so at least one is 32" minimum or change entry to only have one gate for entire width of entry
-regrade and replace entry at gate to provide proper landing slopes

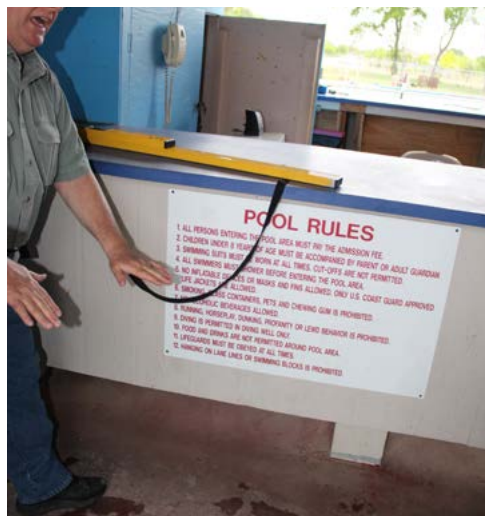
Pool Main Entry

Recommendation:

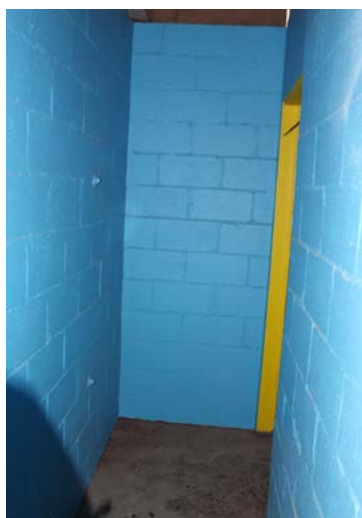
LAKE-INT-2

Entry to locker rooms (both)

Recommendation:

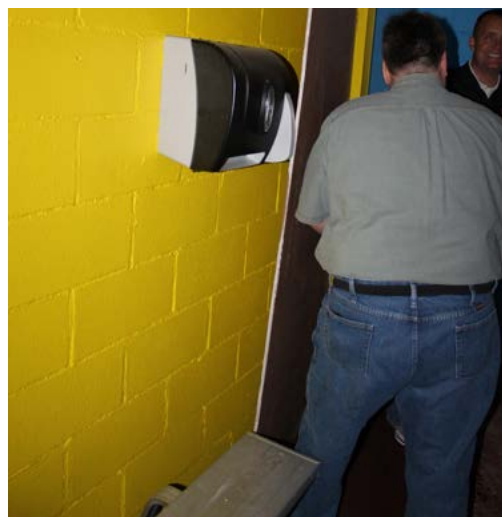
Pool Changing Rooms (Men's and Women's)

Recommendation:

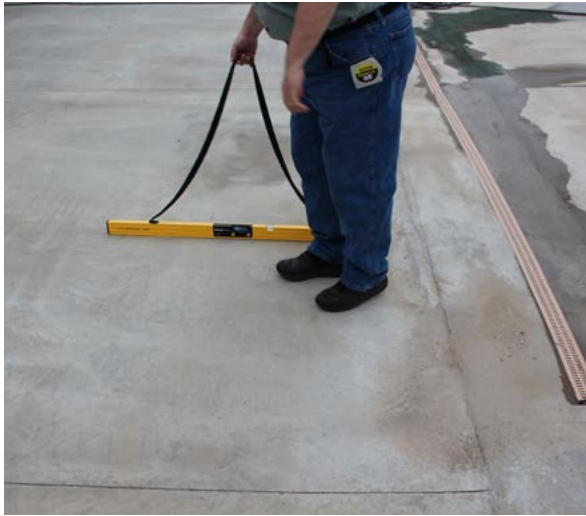
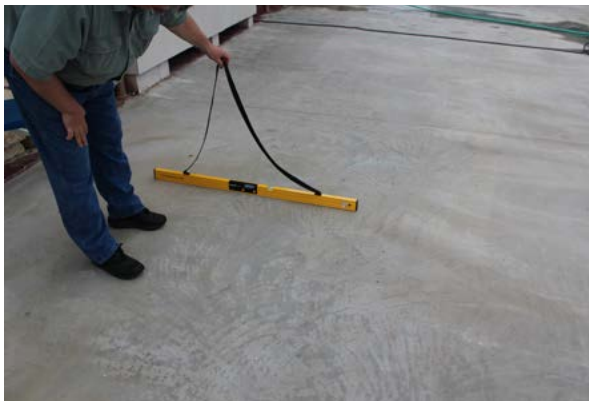
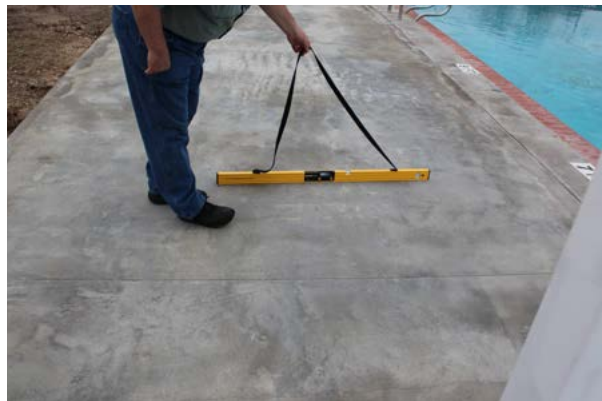
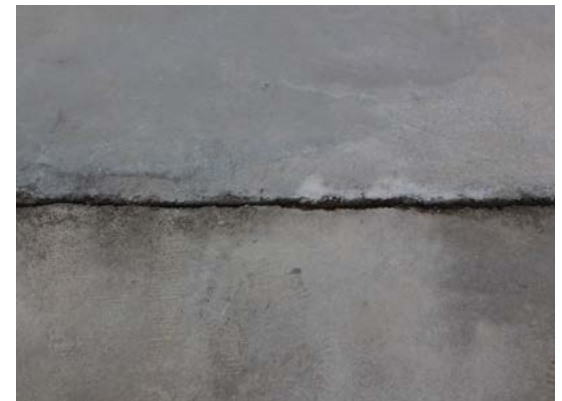
LAKE-EXT-2(a-b)

Pool Deck

- replace and regrade surrounding area to ensure 2% slope in all directions of pool deck
- fill or bevel all joints to ensure smooth surface
