City of Round Rock Parks and Recreation Department ADA Transition Plan (Adopted June 2018)

RE: Parks and Recreation Department ADA Transition Plan

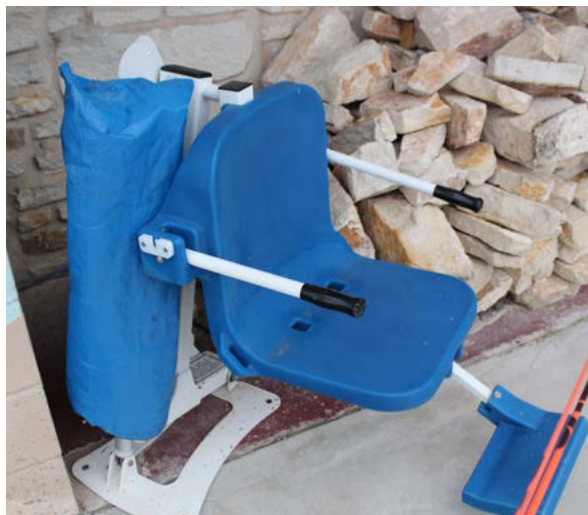
Pool

Recommendation:

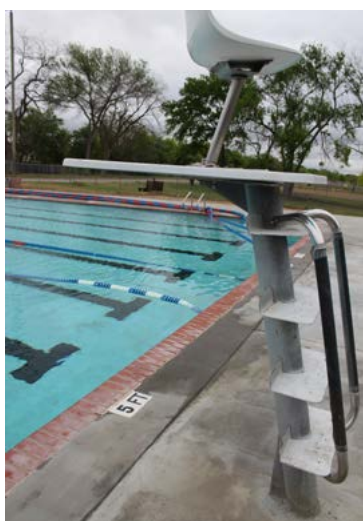
LAKE-EXT-3

Pool Deck

Recommendation:

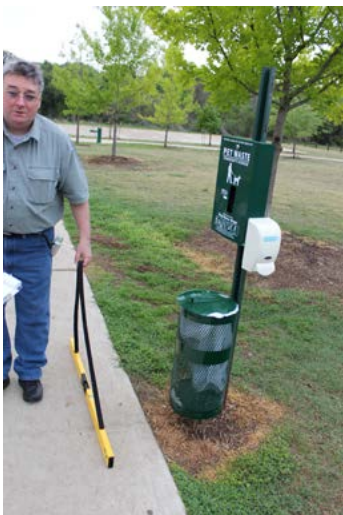
Dog Waste Station

- provide 30"x48" level space at waste station
- replace and regrade surrounding area to ensure proper slope

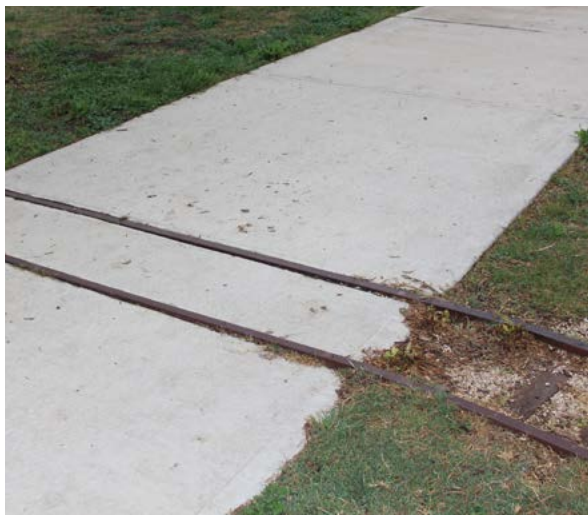
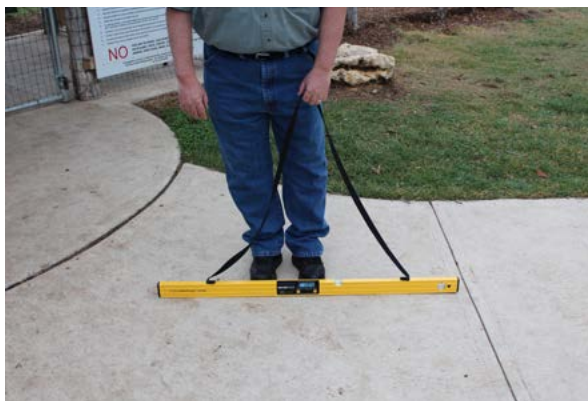
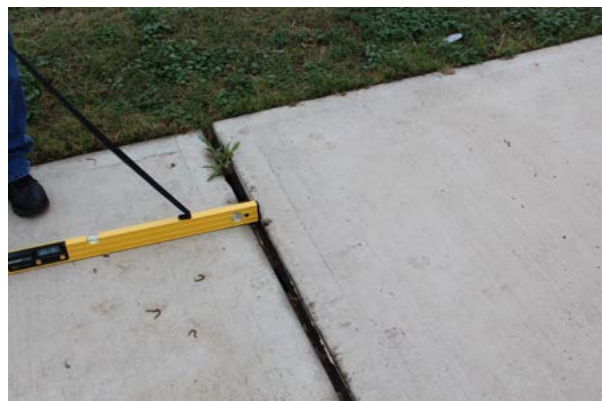
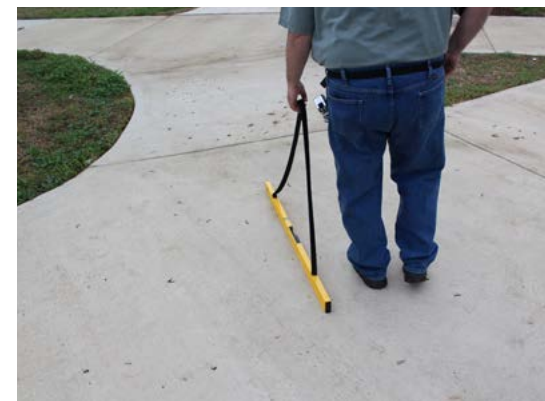
LAKE-EXT-10(a-b)

Dog Park Walkway

- replace and regrade surrounding area to ensure proper slope in all directions of walkway
- fill or bevel all joints to ensure smooth surface

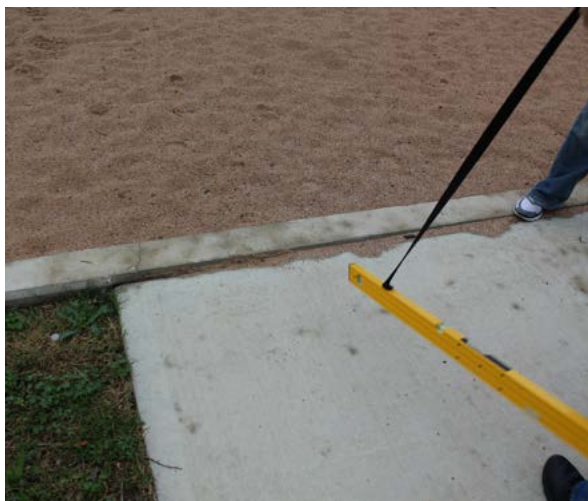
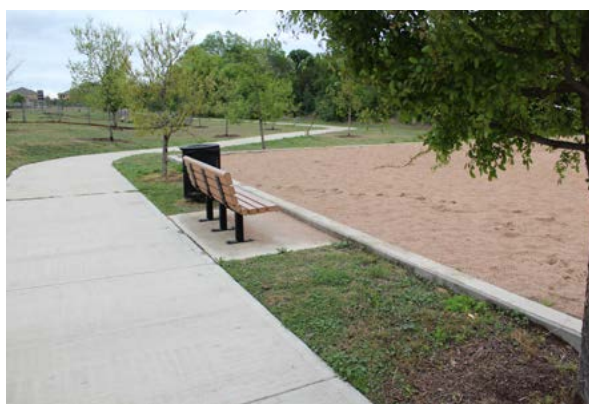
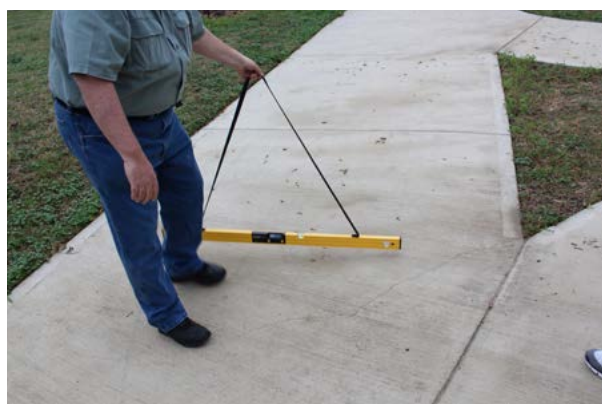
Barrier Number:
LAKE-EXT-11(a-c)

Barrier Location:
Sand Volleyball Court

- replace and regrade surrounding area to ensure proper slope in all directions of walkway
- fill or bevel all joints to ensure smooth surface
- provide at least one 30"x48" clear floor space adjacent to bench

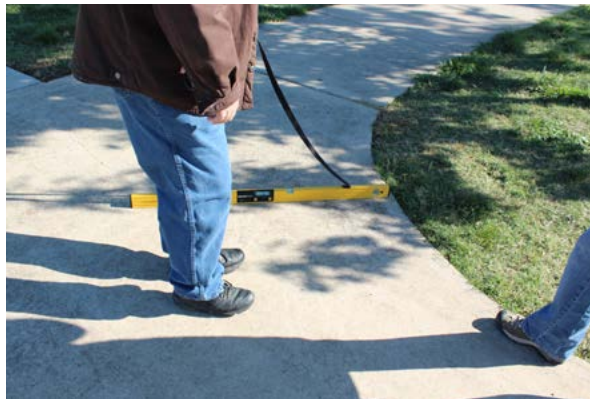
MLAK-EXT-1(a-c)

Accessible Paths and Walkways

- replace and regrade surrounding area to ensure proper slope in all directions of accessible walkway
- b. install colored domes at curb ramp
- c. fill all gaps to provide uniform surface

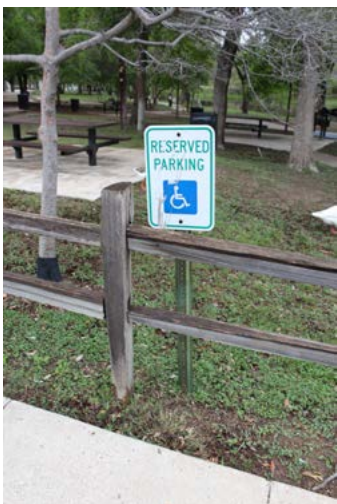
Parking Lot

- replace and regrade surrounding area to ensure proper slope in all directions of accessible parking spaces and adjacent walkway
- raise signage and restripe parking lot

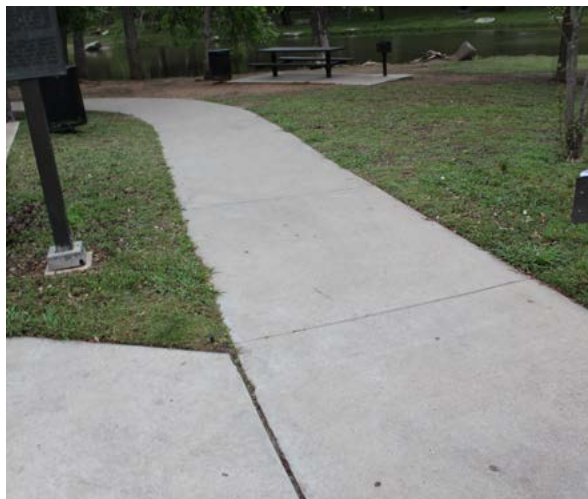
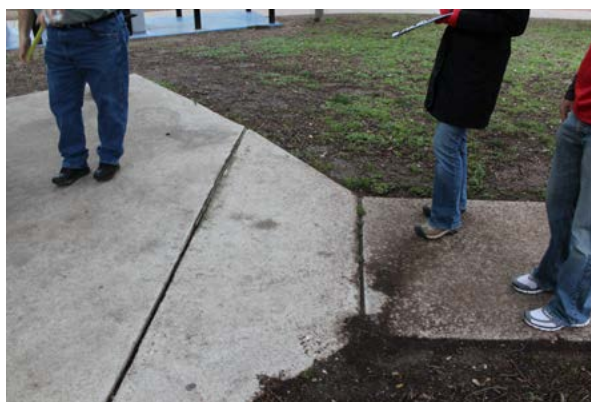
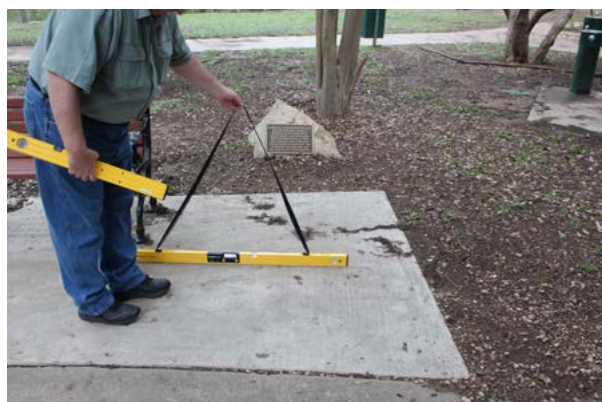
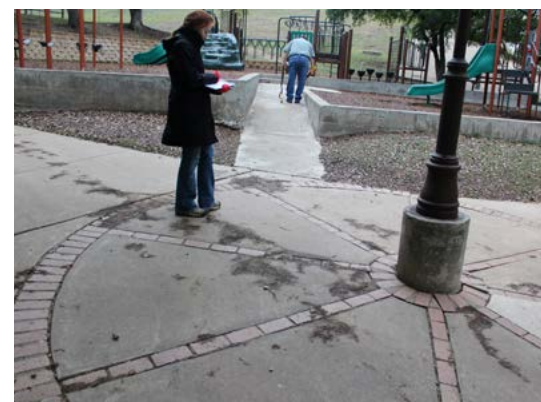
MMRL-EXT-2

Accessible Paths and Walkways (inside main park)

- replace and regrade surrounding area to ensure proper slope in all directions of accessible parking spaces and adjacent walkways

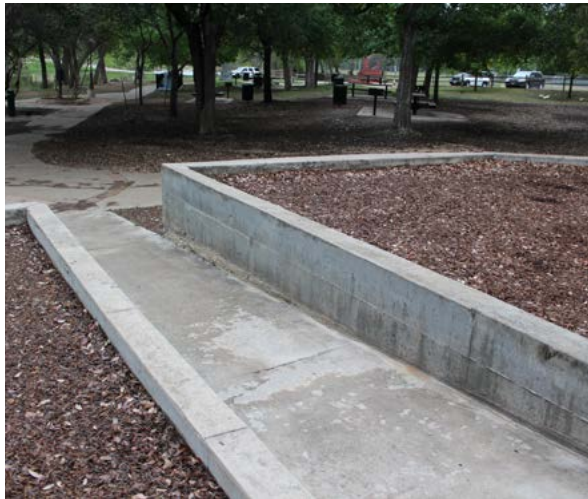
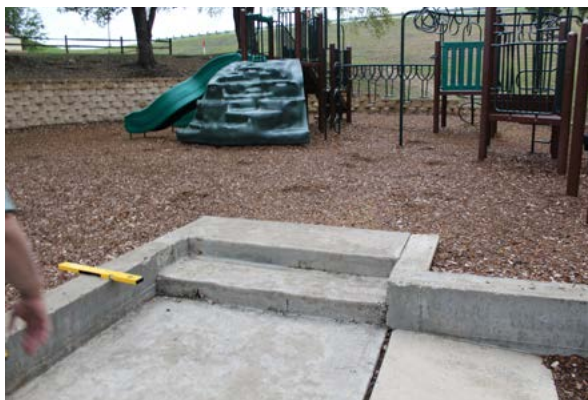
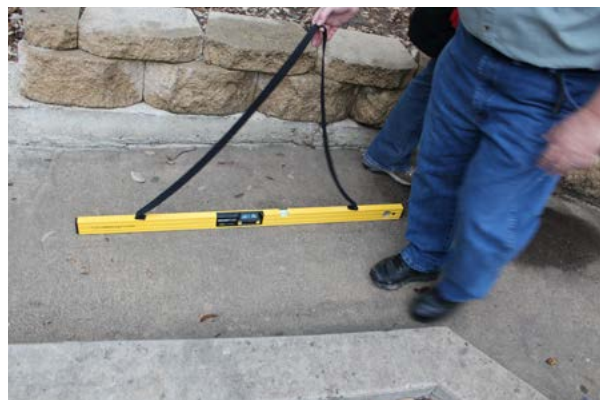
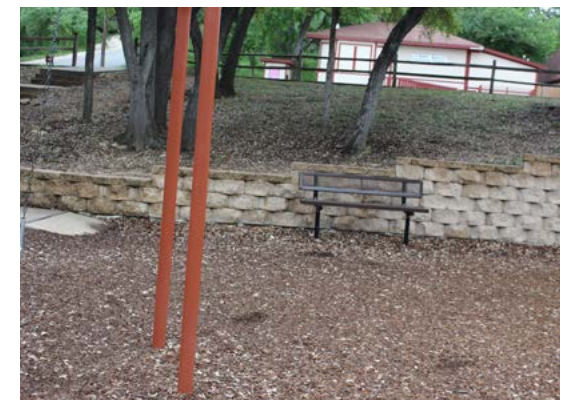
MMRL-EXT-3(a-f)

Playgrounds

- replace and regrade surrounding area to remove ramps and stairs or install landings and handrails
- relocate sign so it does not protrude over walkway
- continue walkway to benches and provide CFS

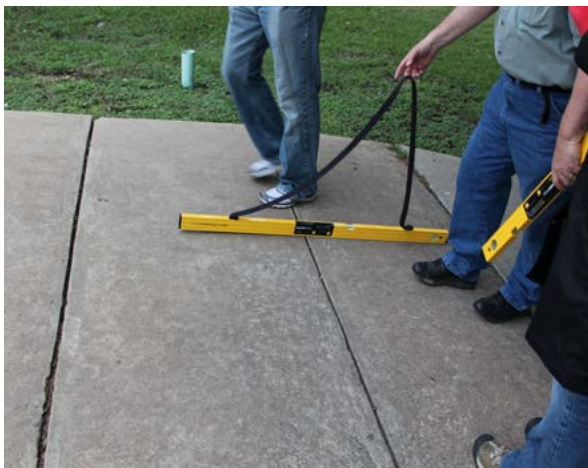
Walkway from park to bridge

- replace and regrade surrounding area to ensure proper slope

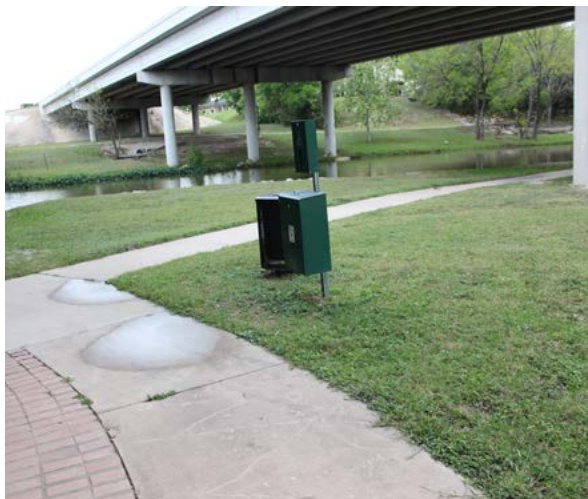
Bridge

- replace and regrade surrounding area to ensure proper slopes at entry to bridge
- fill or bevel all joints to ensure smooth surface
- install handrails on bridge, there are level landings at the ends and center of bridge for ramp

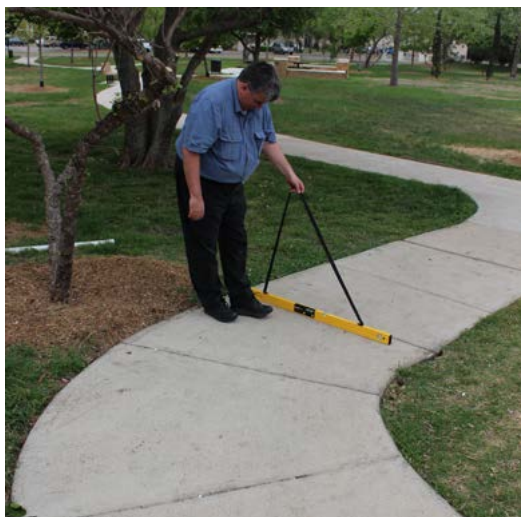
MESA-EXT-1

Sidewalk south of playground

a. large cracks at sidewalks (302.3)

- fill cracks
- regrade and replace surrounding area to ensure proper slopes

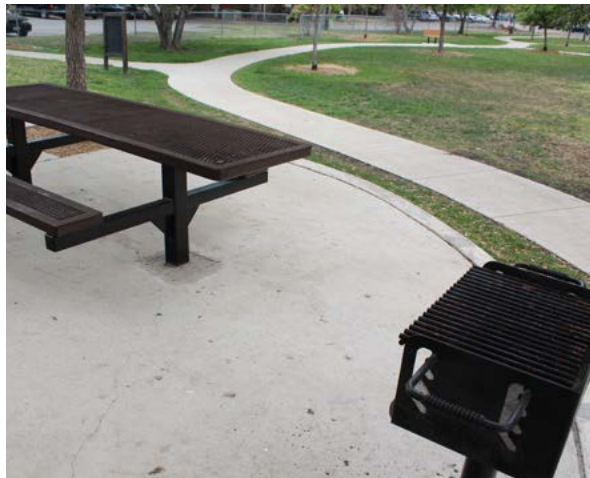
Picnic Grove

- regrade and replace surrounding area to ensure proper slopes

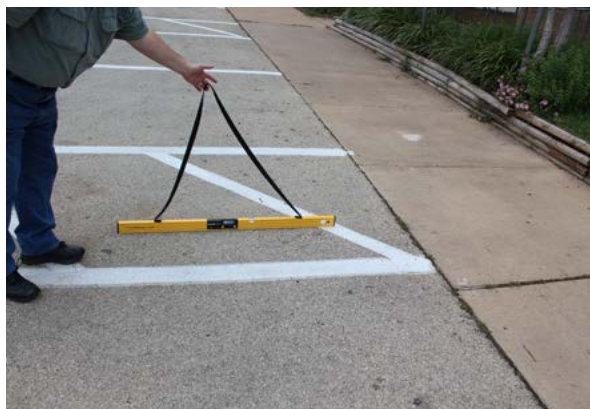
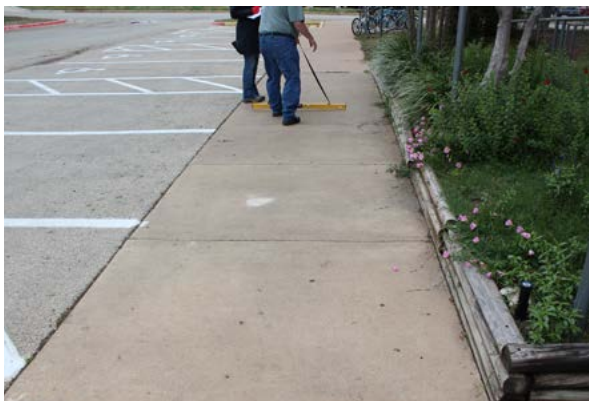
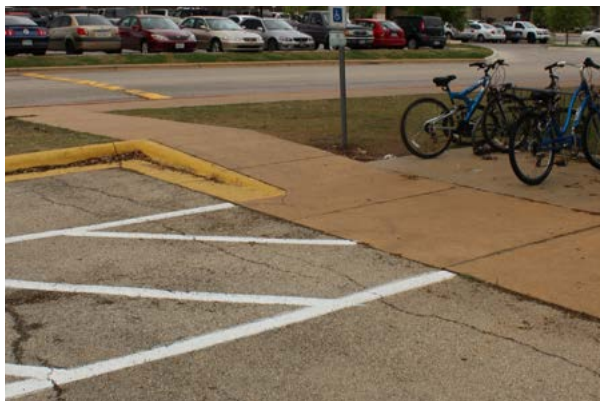
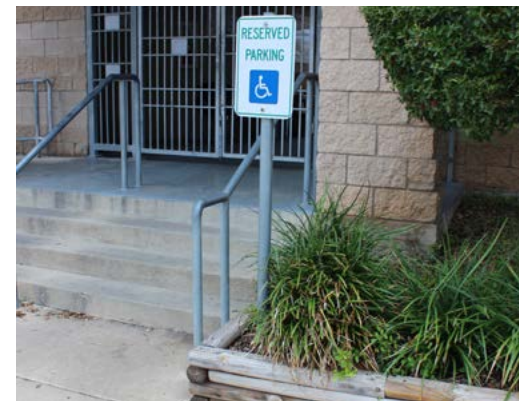
MICK-EXT-1(a-d)

Parking Lot

- replace and regrade surrounding area to ensure proper slope in all directions of accessible parking spaces and adjacent walkways
- raise signage

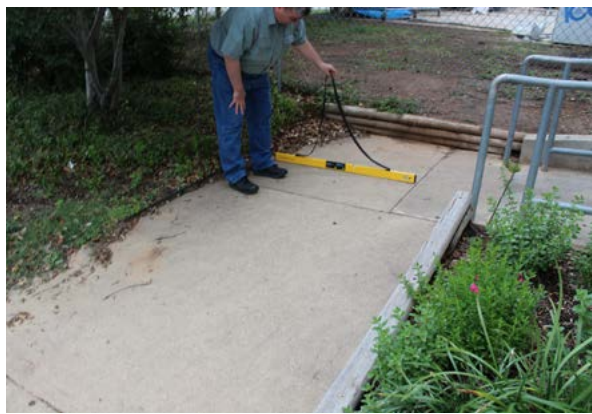
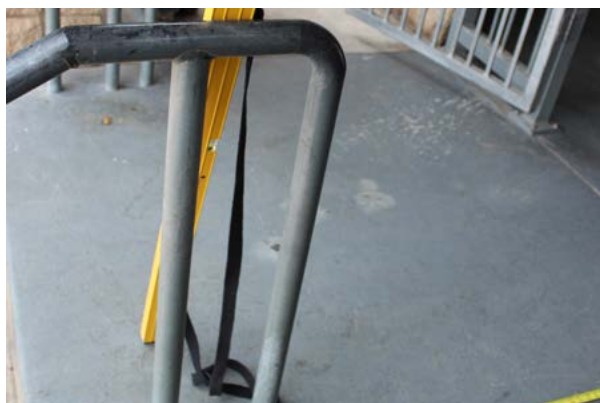
MICK-EXT-2(a-b)

Entrance Ramp

- replace and regrade surrounding area to ensure proper slope on landings and ramp sections
- add 12" extension on handrails

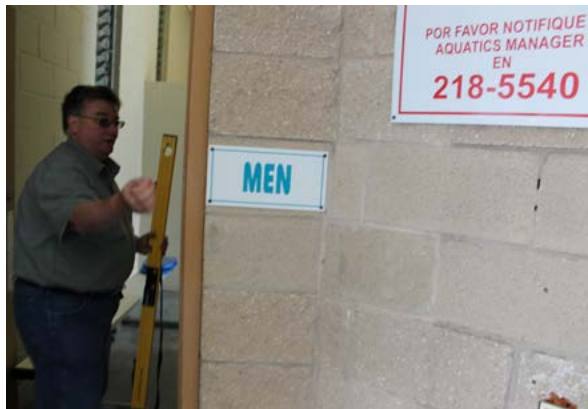
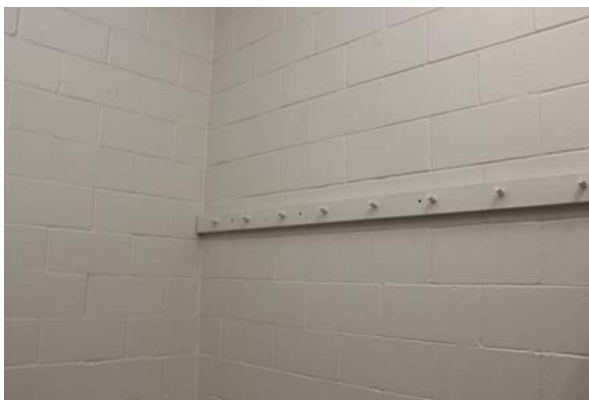
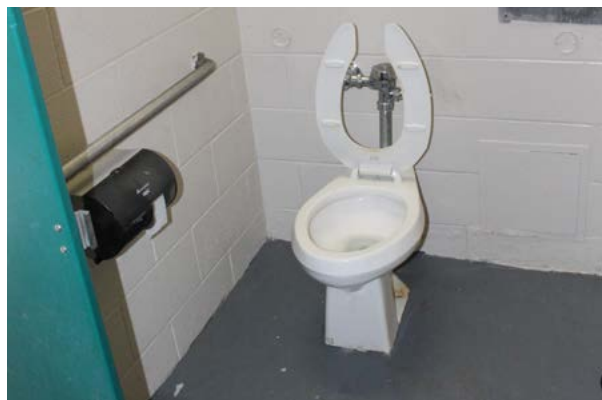
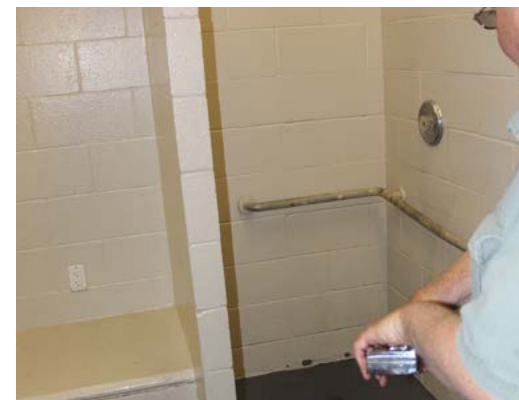
MICK-INT-1(a-h)

Changing Rooms (both)

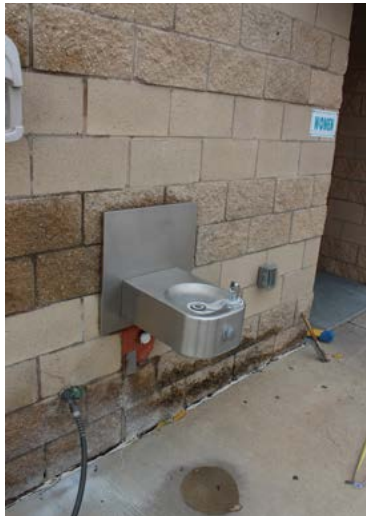
Drinking Fountain

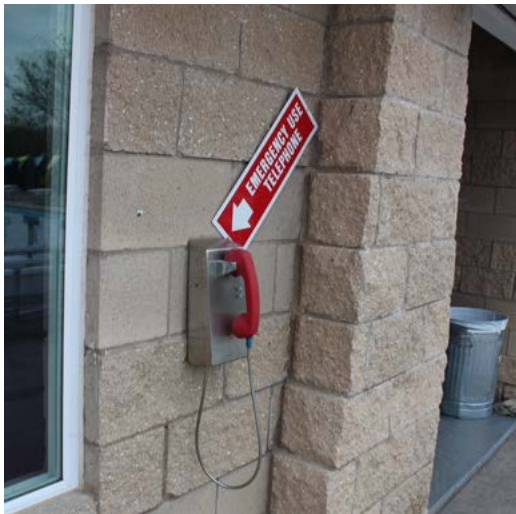
MICK-EXT-3

Telephone

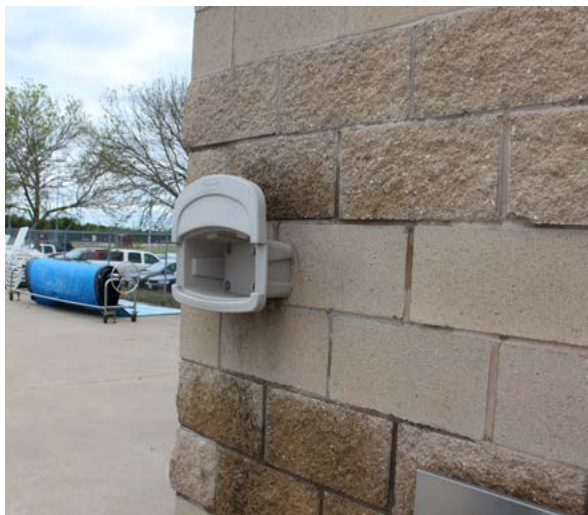
Hose Reel

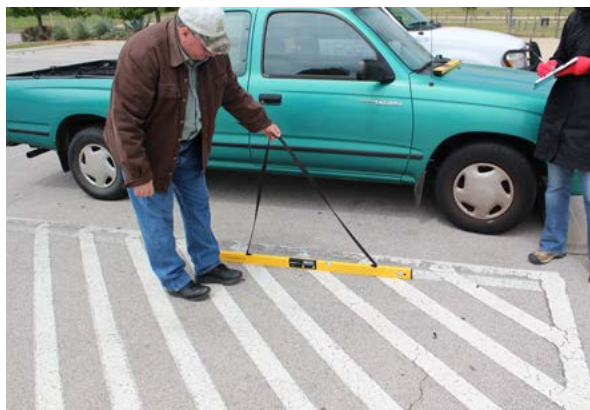
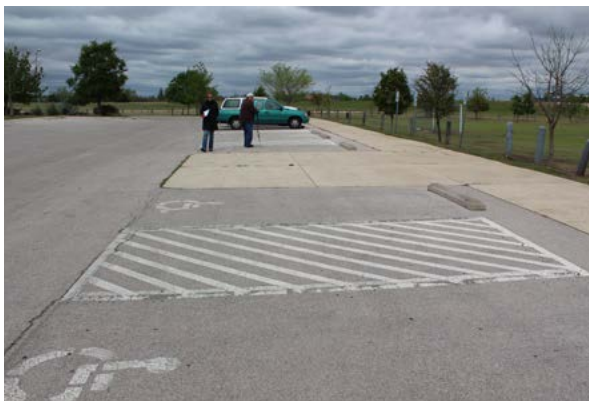
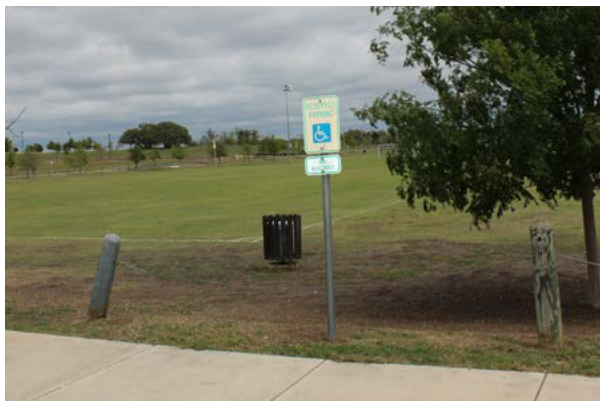
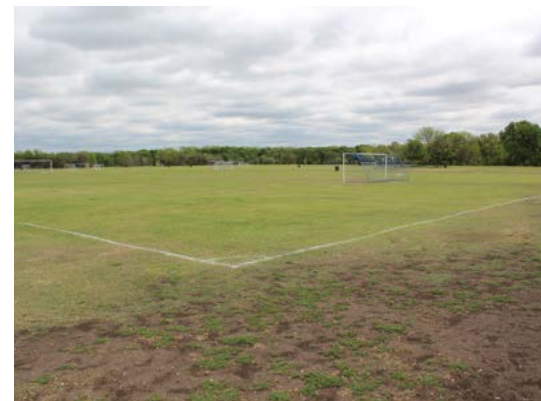
OSPV-EXT-1(a-e)

West Soccer Parking Lot

- replace and regrade surrounding area to ensure proper slope in all directions of accessible parking spaces and adjacent walkways
- raise signage
- restripe lines
- remove gap to provide smooth and uniform surface
- provide accessible route to fields

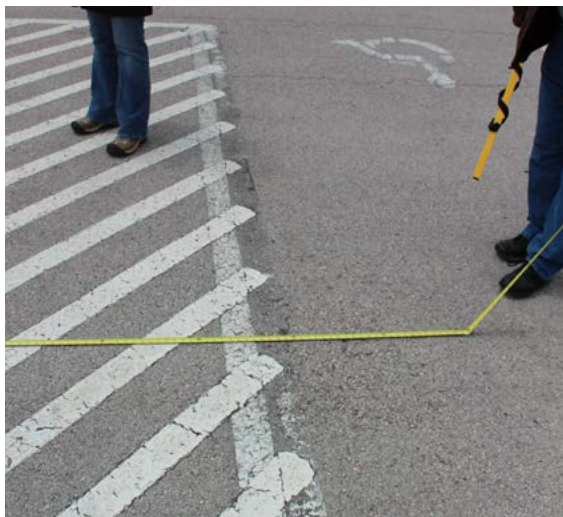
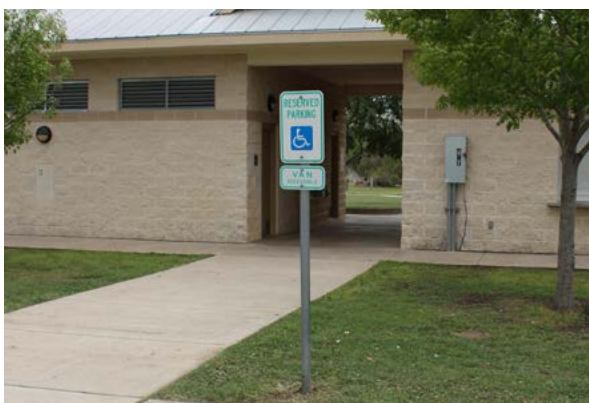
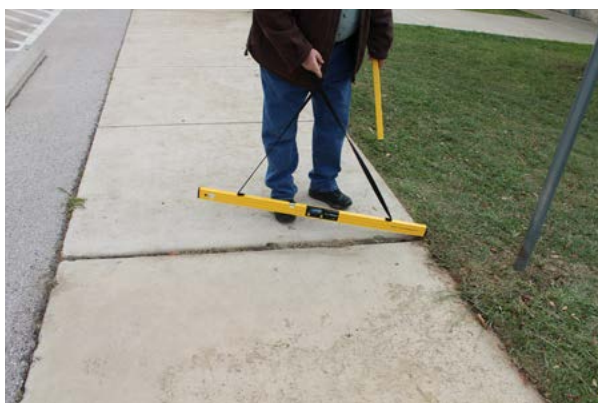
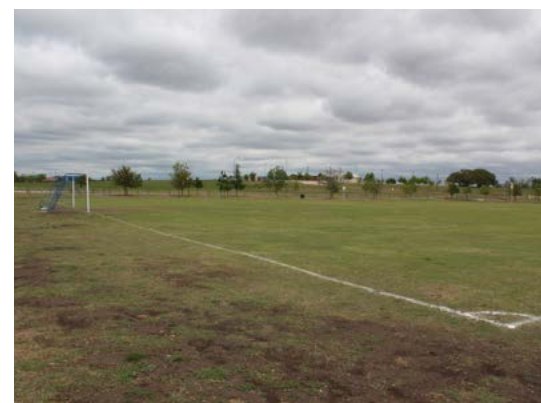
OSPV-EXT-2(a-e)

East Soccer Parking Lot

- replace and regrade surrounding area to ensure proper slope in all directions of accessible parking spaces and adjacent walkways
- raise signage
- restripe lines
- remove gap to provide smooth and uniform surface
- provide accessible route to fields

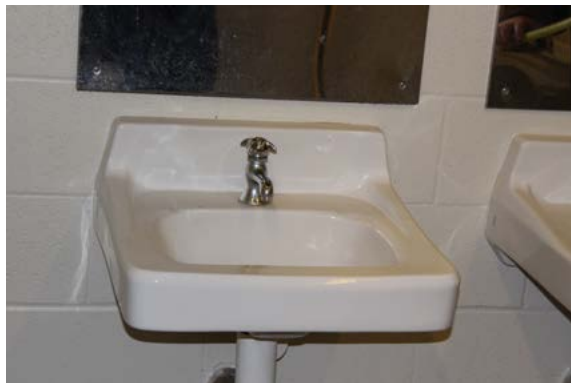
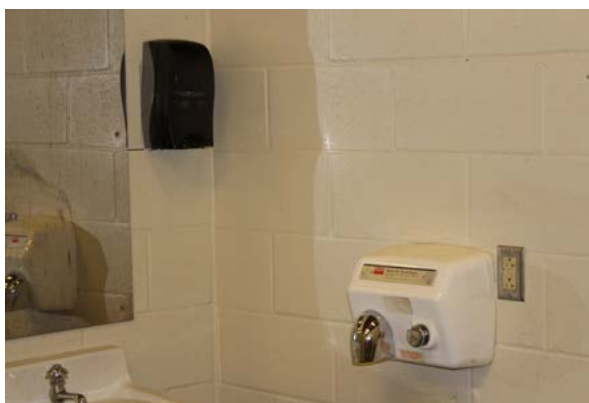
OSPV-INT-1(a-f)

Soccer Restroom (both sides)

- install lever switch on sink
- recess hand dryer or replace with thinner profile dryer
- install flush component on open side of water closet
- move flush component
- wrap sink pipes
- mount all operating parts within reach range

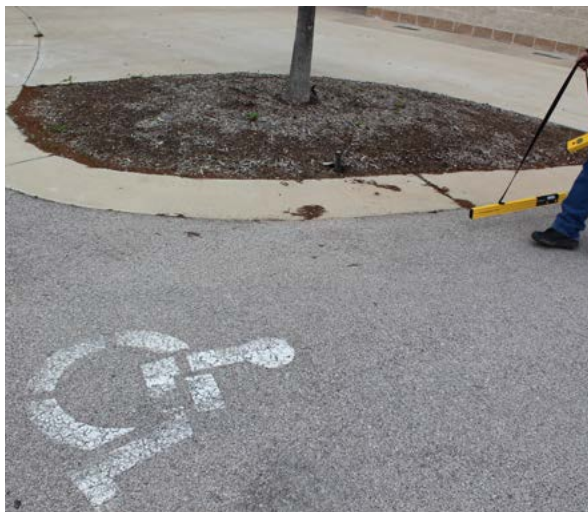
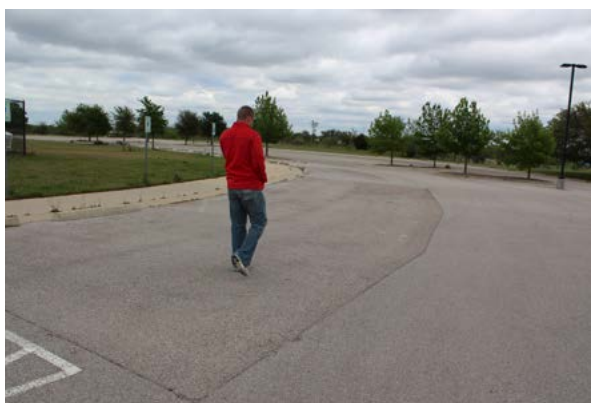
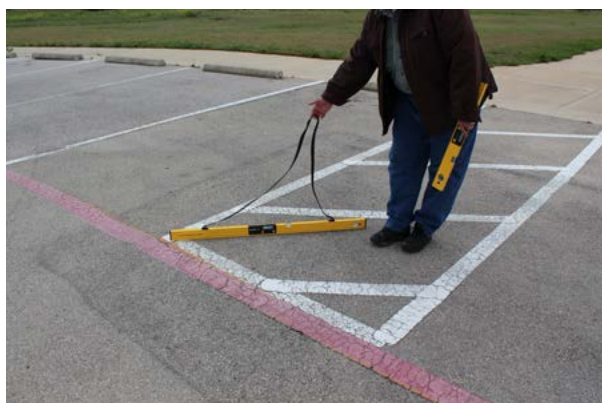
OSPV-EXT-4(a-d)

Rock N River Parking Lot

- replace and regrade surrounding area to ensure proper slope in all directions of accessible parking spaces and adjacent walkways
- raise signage
- restripe lines

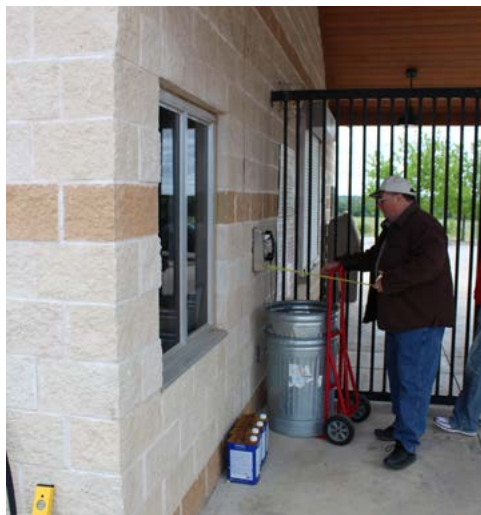
Phone at entry to Rock N River

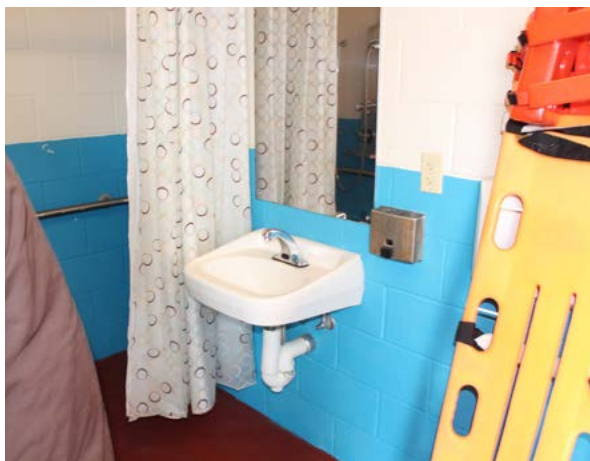
OSPV-EXT-5

Rock N River Old Family Restroom

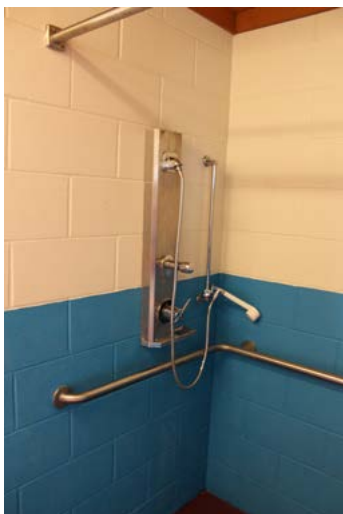
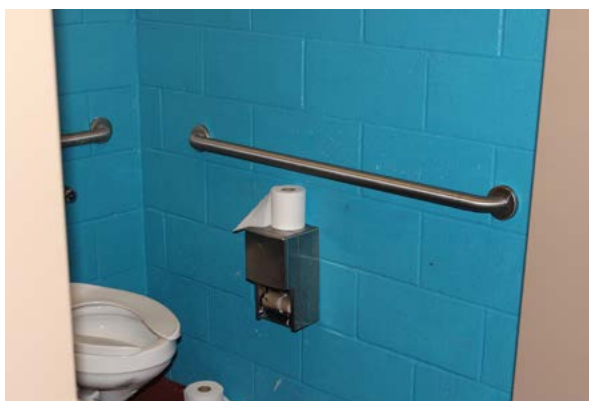
OSPV-INT-3(a-d)

Rock N River Old Bath House

- replace hand held device with compliant model and ensure operable parts are max 48"
- replace ADA lockers with compliant model
- relocate paper roll to 7-9 from toilet
- raise curtain rods to 80" min

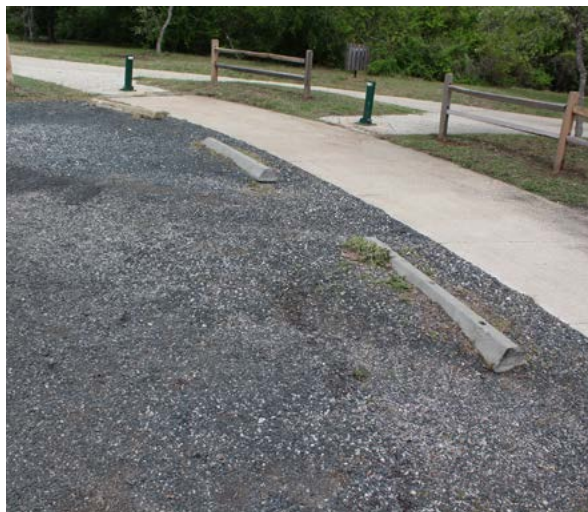
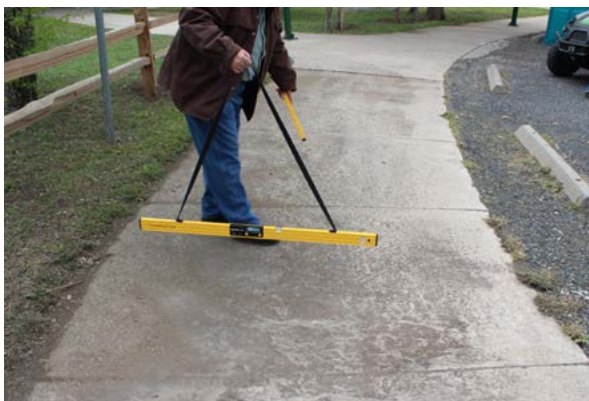
OSPV-EXT-5(a-e)

Rabb Pavilion Parking Lot

- replace and regrade surrounding area to ensure proper slope in all directions of accessible parking spaces and adjacent walkways
- stabilize surface area
- restripe lines

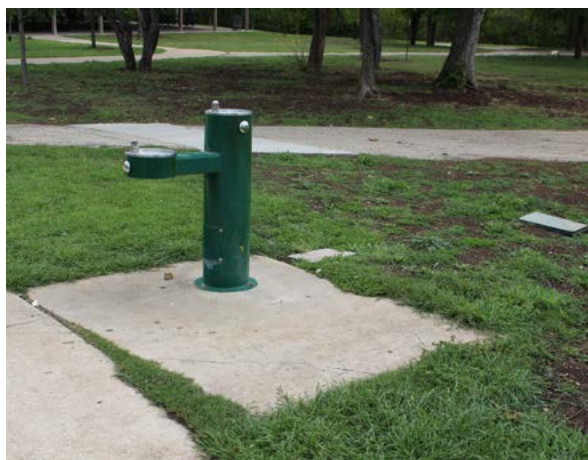
OSPV-EXT-9(a-b)

Rabb Pavilion Area Drinking Fountain

- replace and regrade surrounding area to ensure proper slope in all directions

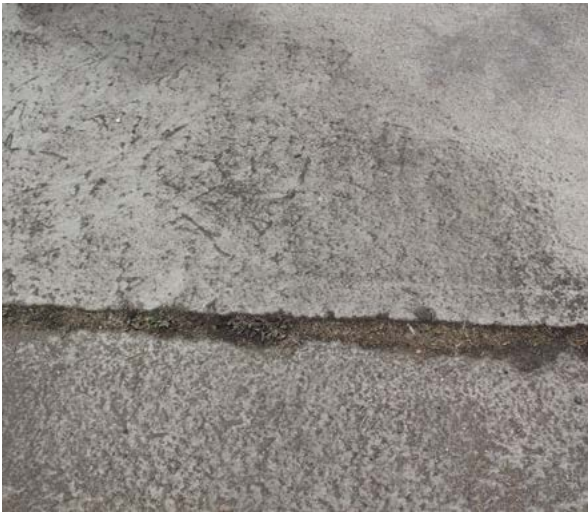
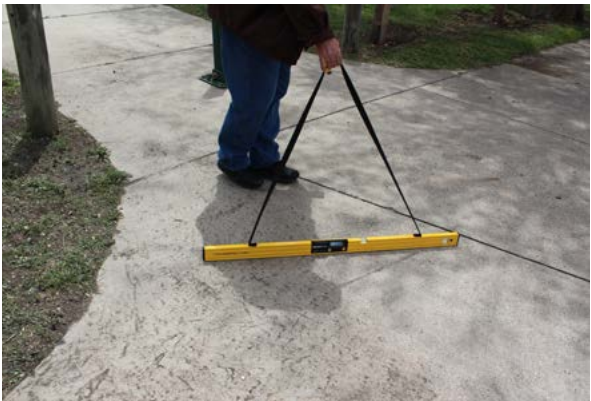
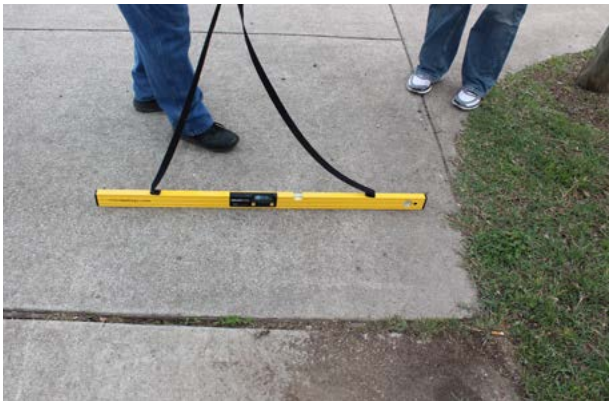
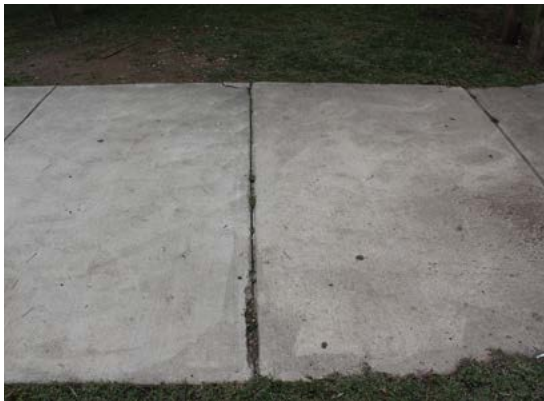
Barrier Number:
OSPV-EXT-11(a-b)

Barrier Location:
Rabb Pavilion Area Accessible Routes

Barrier Description:
a. intersection at pavilion and parking cross slope too steep (403.3)
b. gaps where wood joints have disintegrated (302.3)

Recommendation:
- replace and regrade surrounding area to ensure proper slope in all directions
- fill in and seal all joints missing wood

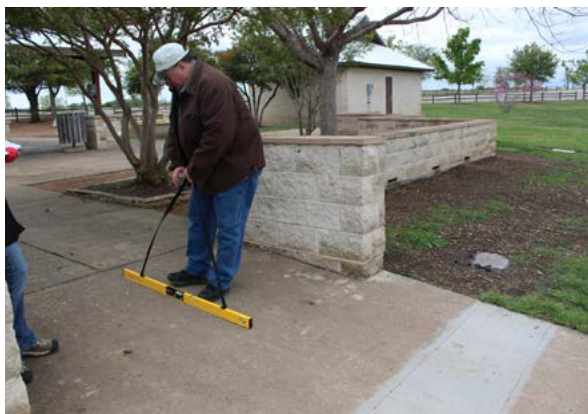
OSPV-EXT-13

Lakeview Pavilion to Trail

- replace and regrade surrounding area to ensure proper slope in all walkways

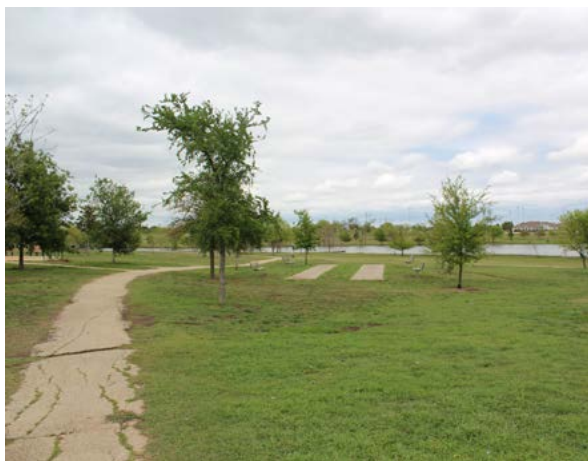
OSPV-EXT-14

Shuffle Board near Lakeview Pavilion

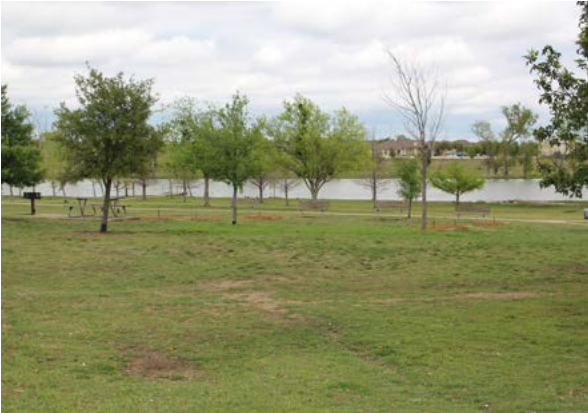
Barrier Location:
Horseshoes near Joanne Land Playground

Barrier Description:
a. no accessible route to horseshoes (402)

Recommendation:
- provide accessible route to horseshoes

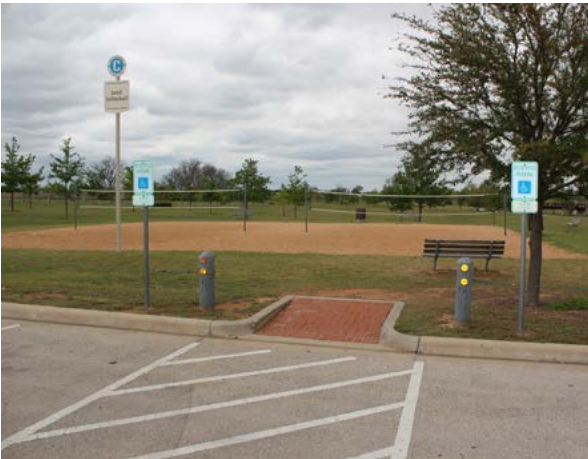
Barrier Number:
OSPV-EXT-16

Barrier Location:
Sand Volleyball

Barrier Description:
a. no accessible route to volleyball courts (402)
b. cross slopes of parking is too steep (403.3)
c. signs are too low (502.6)

Recommendation:
- install accessible route to shuffle boards and surrounding amenities
- replace and regrade surrounding area to ensure proper slope in all directions of accessible parking spaces and adjacent walkways
- raise signs

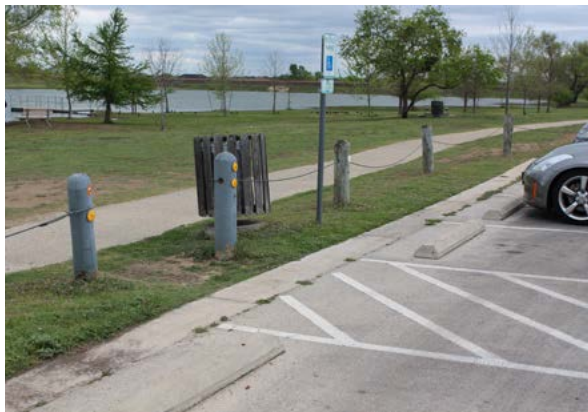
ADA parking near fishing dock

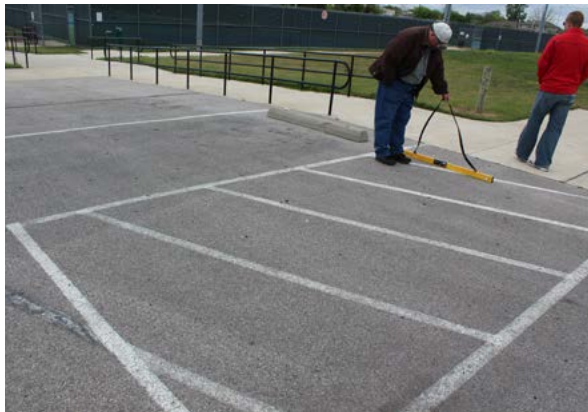
Tennis Complex Parking Lot

- replace and regrade surrounding area to ensure proper slope in all directions of accessible parking spaces and adjacent walkways
- raise signs

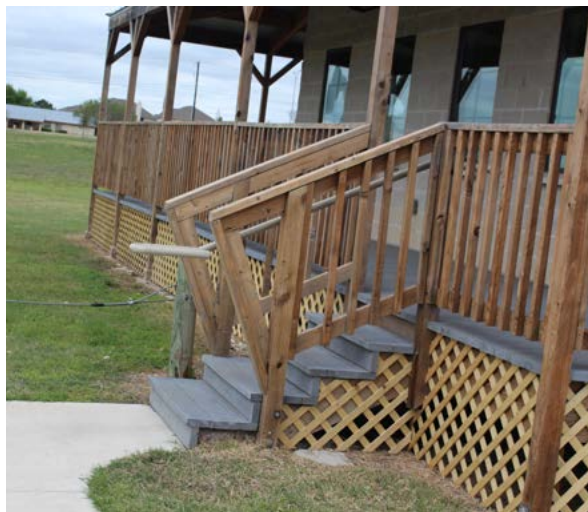
Tennis Pro Shop

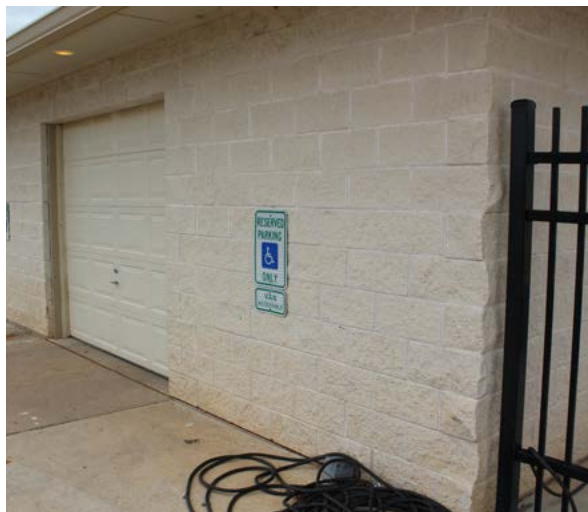
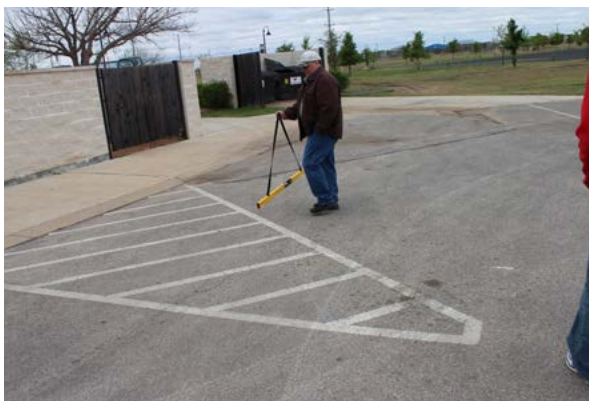
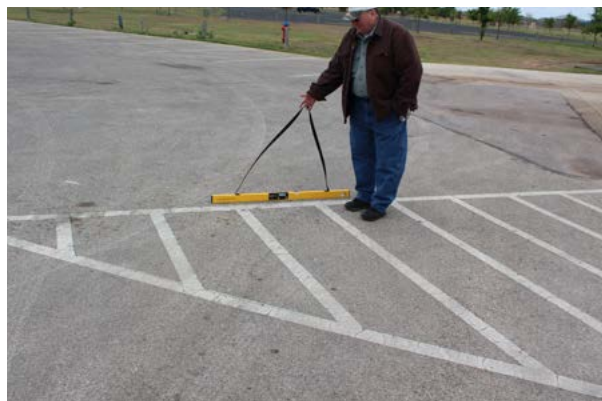
OSPV-EXT-20(a-c)

Barrier Location:
Silver Slugger Parking Lot

- replace and regrade surrounding area to ensure proper slope in all directions of accessible parking spaces and access aisles
- raise parking signs
- restripe lines

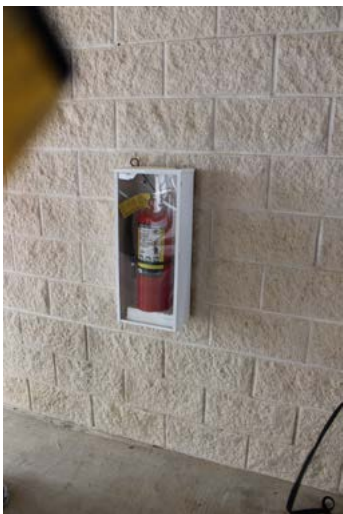
Silver Slugger Concessions Building

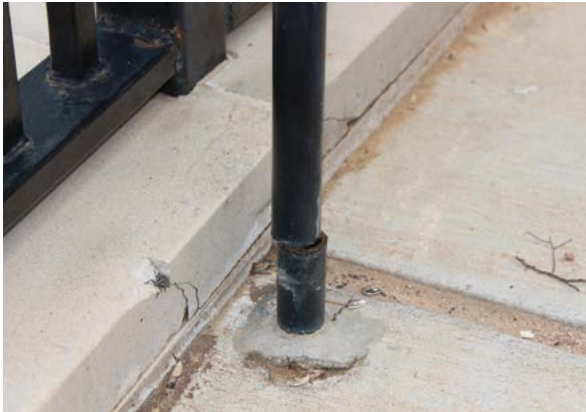
**Barrier Location:**

Silver Slugger Champion Field

a. rail post at top of ramp is damaged

Recommendation:

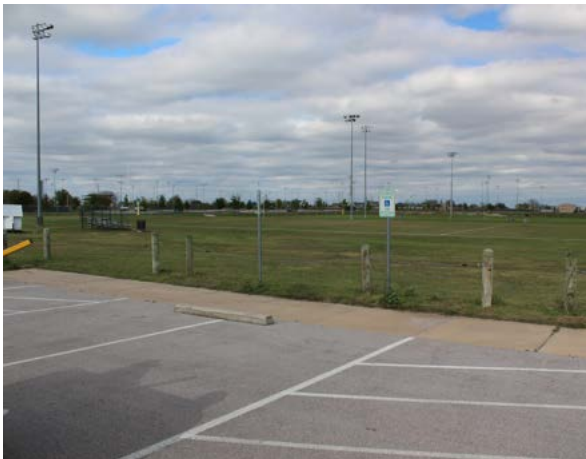
OSPV-EXT-21

**Barrier Location:**

Football Fields

Recommendation:

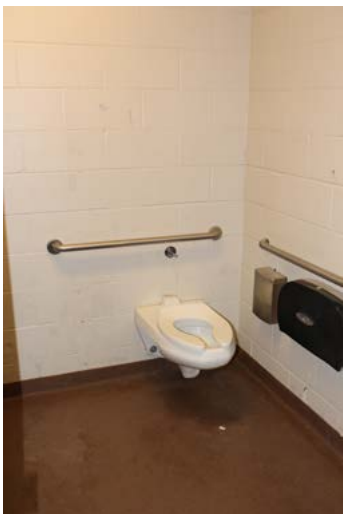
Barrier Location:

Cy Young Concessions Building

Recommendation:

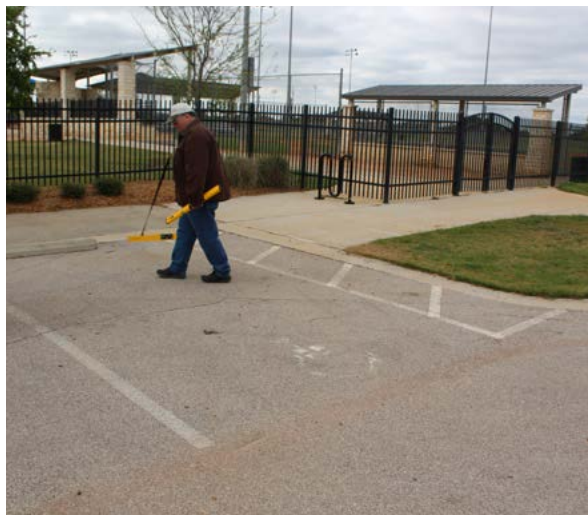
**Barrier Location:**

Cy Young Parking Lot

- a. signs are too low (502.6)
- b. striping is faded (502.3.3)
- c. missing van access (502.3)
- d. running slope of ramp is too steep (406.2)

Recommendation:

- raise signs
- restripe parking and add van access during restripe
- replace and regrade surrounding area to ensure proper slopes on curb ramp

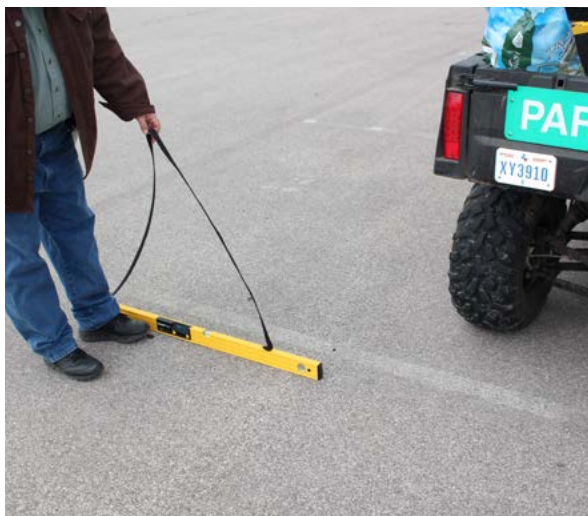
Barrier Location:

Hall of Fame Parking Lot

Recommendation:

- replace and regrade surrounding area to ensure proper slopes on all parking spots and access aisles
- caulk or fill gaps at ramp joints

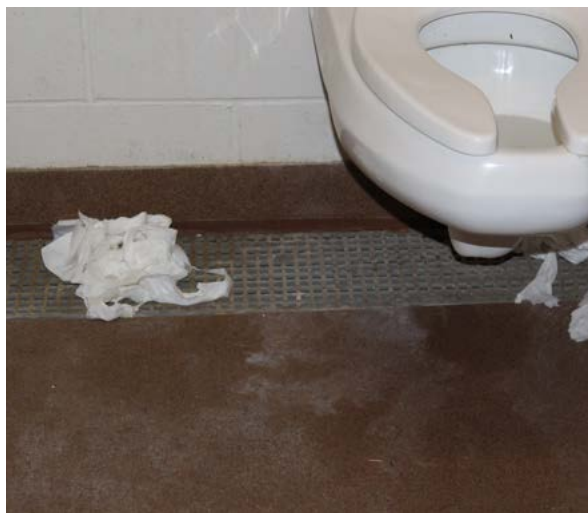
Barrier Location:

Hall of Fame Concessions Building

Recommendation:

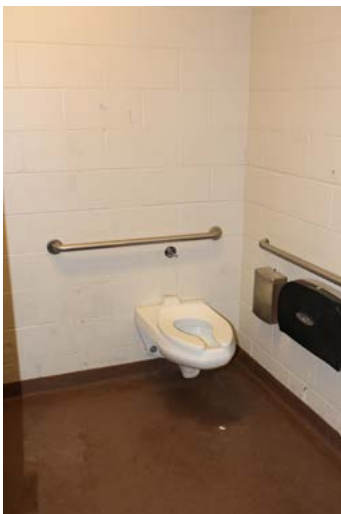
Barrier Location:

Gold Glove Concessions Building

Recommendation:

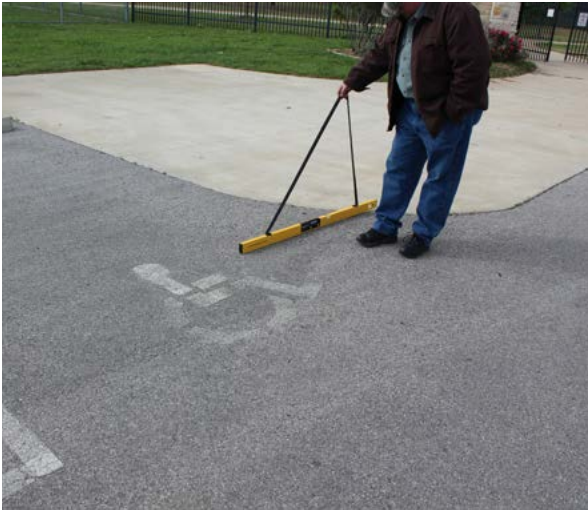
Barrier Location:
Triple Crown Parking Lot

- Barrier Description:**
- a. uneven surface in one parking spot (502.4)
 - b. change in level from spot to access aisle (303.2)
 - c. change in level at parking spot (303.2)
 - d. lines are faded (502.3.3)
 - e. no accessible route to fire extinguisher (402)

- Recommendation:**
- remove all changes in level
 - replace surface to provide smooth, uniform surface
 - restripe lines

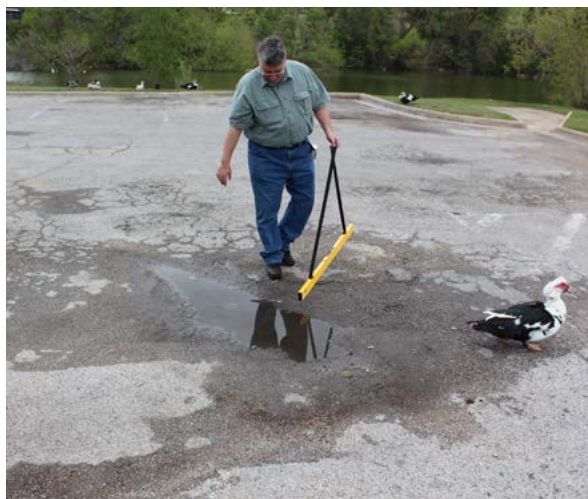
Barrier Location:

Parking Lot

- slope at accessible parking is too steep (403.3)
- large pot hole in accessible parking (302.3)
- missing van access sign (502.6)
- ramp protrudes into access aisle (502.3)

Recommendation:

- replace and regrade surrounding area to ensure proper slopes at accessible parking and access aisle
- fill all potholes to ensure smooth and uniform surface
- add necessary van signage

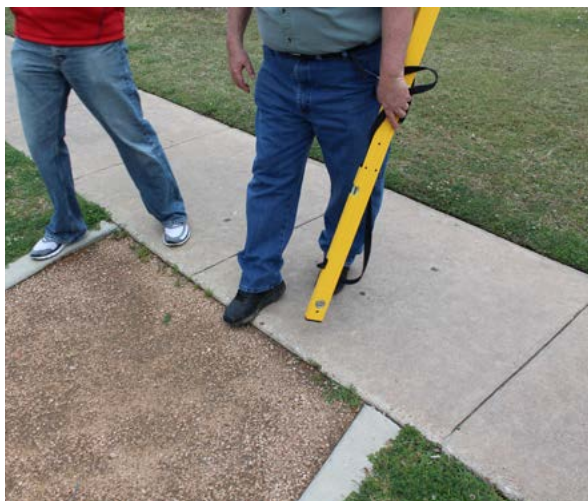
Barrier Location:

Accessible Routes

Recommendation:

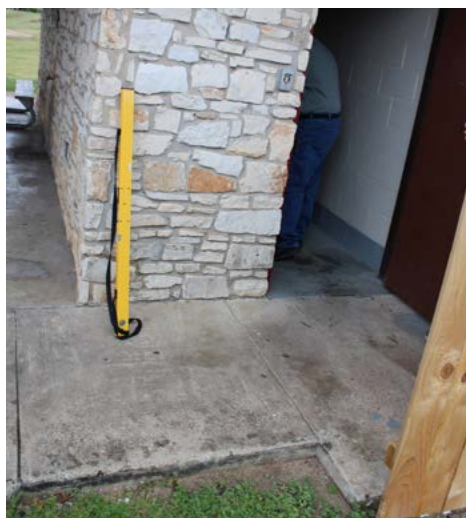
Barrier Location:

Restrooms (both)

Recommendation:

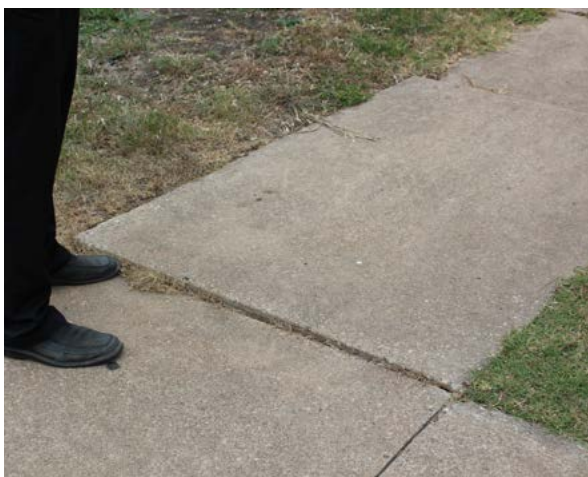
Tennis Sidewalk

Barrier Location:

- replace sidewalk with compliant sidewalk, free from changes in level and assuring proper slopes
