City of Round Rock Parks and Recreation Department ADA Transition Plan (Adopted June 2018)

RE: Parks and Recreation Department ADA Transition Plan

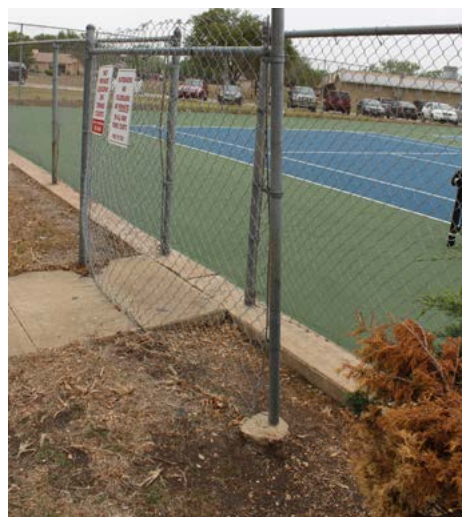
STRK-EXT-1(a-b)

Tennis Entry

- replace fence sallyport with accessible gate structure

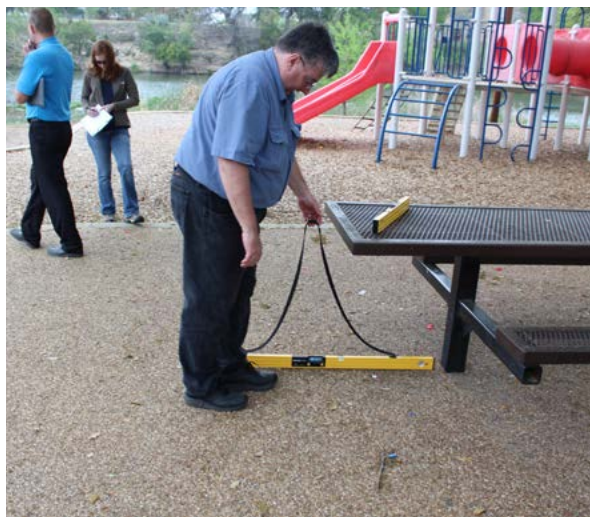
VETP-EXT-3

Picnic table near playground

- regrade and replace surrounding area to provide proper CFS at bench

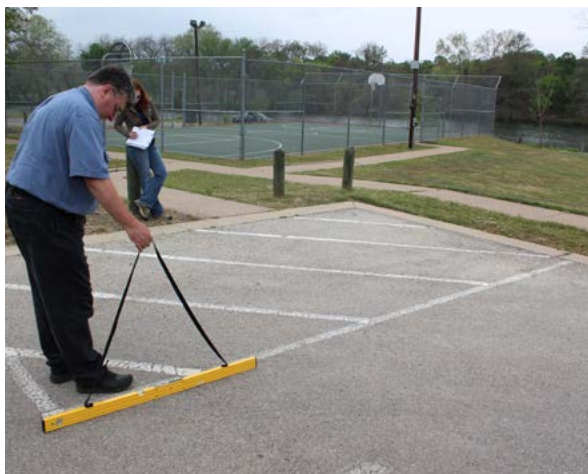
Parking lot along road near basketball

Barrier Location:

- regrade and replace surrounding area to ensure proper slopes at parking space

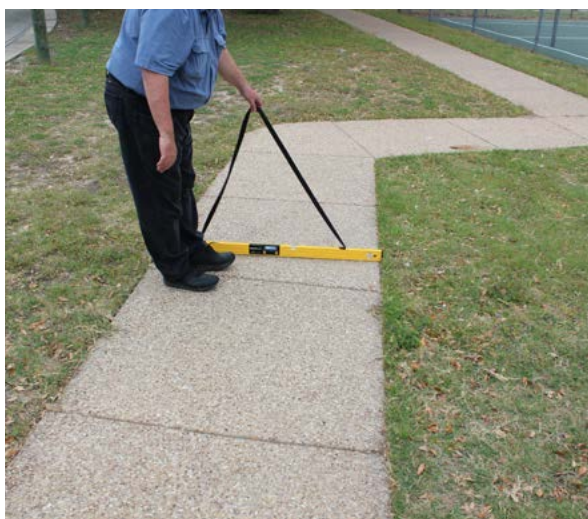
VETP-EXT-5(a-b)

Sidewalk to Basketball Court

- regrade and replace surrounding area to provide proper slopes

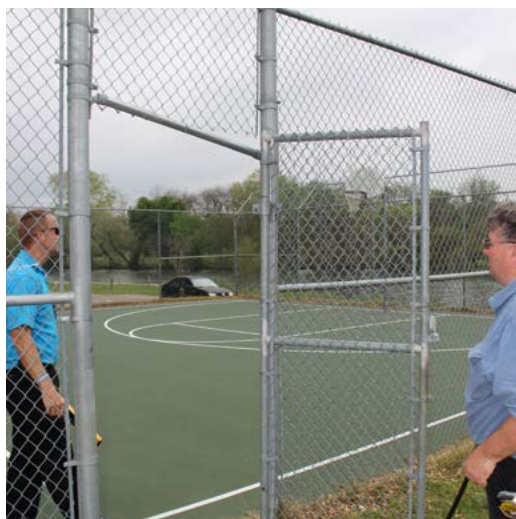
Basketball Court

Barrier Location:

- replace fence gate with a double swing gate

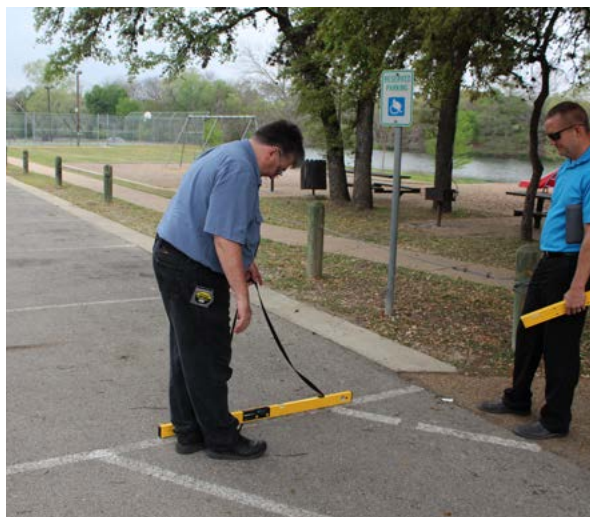
VETP-EXT-7

Main Entrance

- regrade and replace surrounding area to provide proper slopes
