# Round Rock Stagecoach Inn

Round Rock, Texas

## Relocation Feasibility Study

December 5, 2016

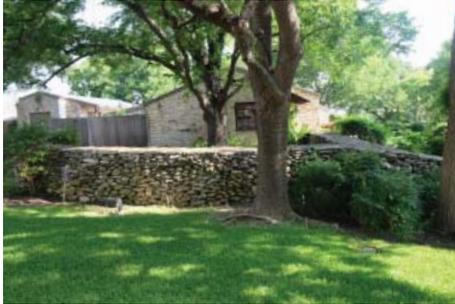
Stacked rock wall at south side

*Depending on the new location, the dry stacked wall could be salvaged and reassembled at the discretion of the City of Round Rock. The pavers are set in a bed of concrete and will not be practical to relocate.*

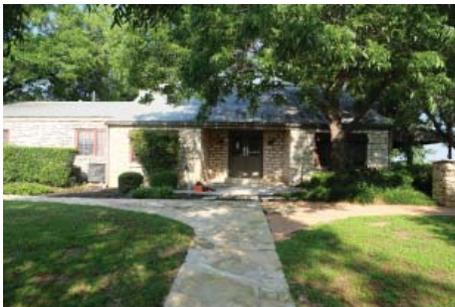
Vegetation and mature trees at east side

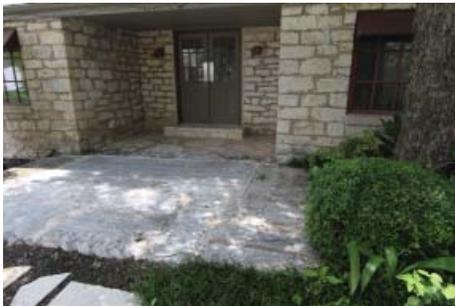
Large stones at entryway of east side

*The large stones in front of the east door should be salvaged and moved with the building. Historic photographs show a stone platform in front of this entry and the size of the stones and the large size of the stones indicate that they may be historic.*

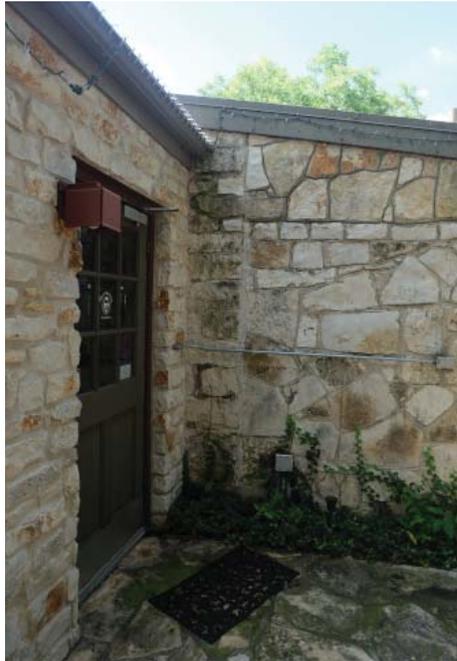
Change in stone from historic building (left) to new addition (right) at north side

The original limestone walls appear to be in good condition. The mortar varies in color and is generally spread over the face of the limestone blocks at the mortar joints.

*The limestone on the additions should be surveyed and evaluated to determine if any was repurposed from demolished historical exterior walls. Any new limestone from the additions should be demolished. It is recommended that a qualified architectural conservator conduct mortar analysis to determine the color and composition of the original mortar for repointing. Generally, a type N mortar is appropriate for exterior limestone.*

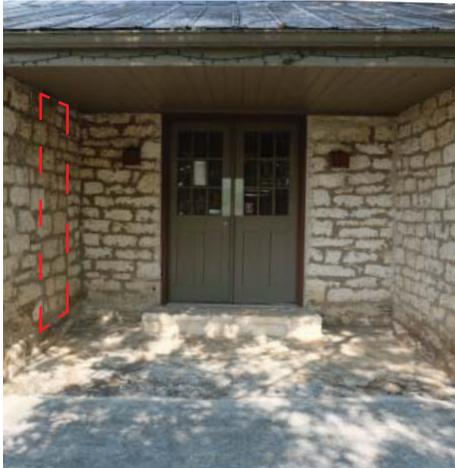
Original door opening with modern doors at east elevation; Dotted red outline of possible historic door at left

The existing doors are on good condition. Historic photographs show single doors at the west and south sides of the building. These doors were removed when additions were added. There is an outline in the masonry of a single door opening to the south of the main doors.

*It is recommended that all of the door openings be restored when the building is stabilized after relocation. The new doors should be historically appropriate. In historic photographs, it appears that there may have been screen doors; although the historic doors are difficult to clearly see in photographs. The outlined door opening south of the entryway may be interpreted as historic and reconstructed.*

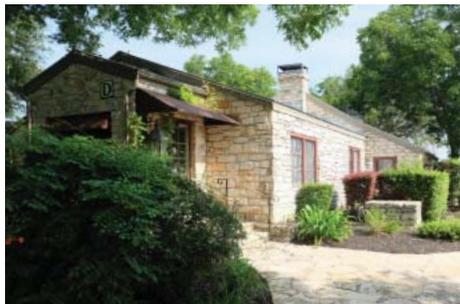
South additions

The additions are in good condition.

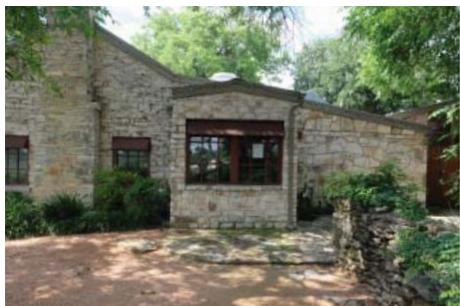
North and west additions

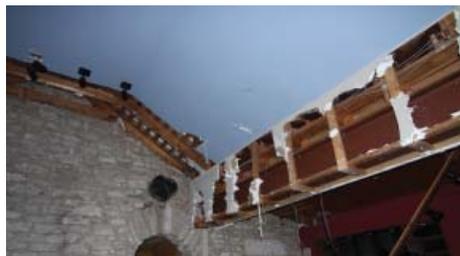
Exposed steel I-beam, looking southwest

The broken gable of the roof structure is supported at the west side of the room with a steel I-beam and at the east side of the room with a wooden box beam resting on the two extruding masonry walls flanking the main doors.

The interior walls and finishes are worn but are in overall good condition. Upon selective removal of the gyp board, the exposed roof structure appears modern and no historical material was visible; however, the roof pitch does appear to be consistent with the historic roof.

*The modern roof construction can be maintained during the move and after relocation. The building most likely originally had a pole and rafter roof construction. Historical documentation mentions beams made of hand-hewn oak. The historic roof construction is beyond the scope of this report and its reconstruction is depending on future programming needs and interpretation philosophies, as they are determined.*

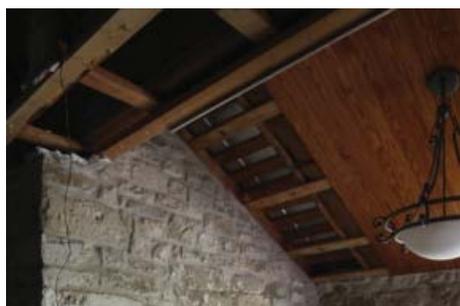
Exposed roof construction at southeast corner of main room

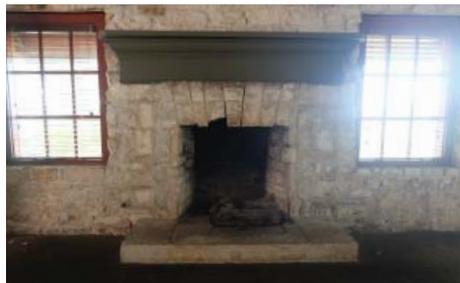
North fireplace with painted mantel and chipped masonry

The fireplaces are in fair condition. There is a large chipped stone at the north mantel. There appear to be indications in the mortar joints of where an earlier mantel may have been.

*After relocation, the modern mantels should be removed and eventually replaced with a historically appropriate piece. The fireplaces require cleaning. Metal chimney caps should be placed and maintained on the top of the chimney stacks to avoid water and pest intrusion.*

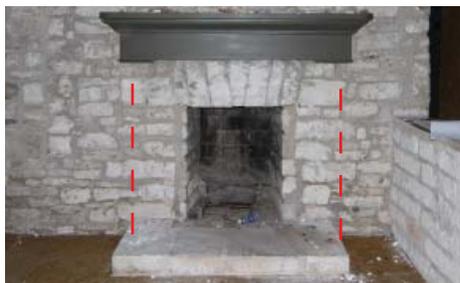
South fireplace with red lines indicating the outline of an early mantel

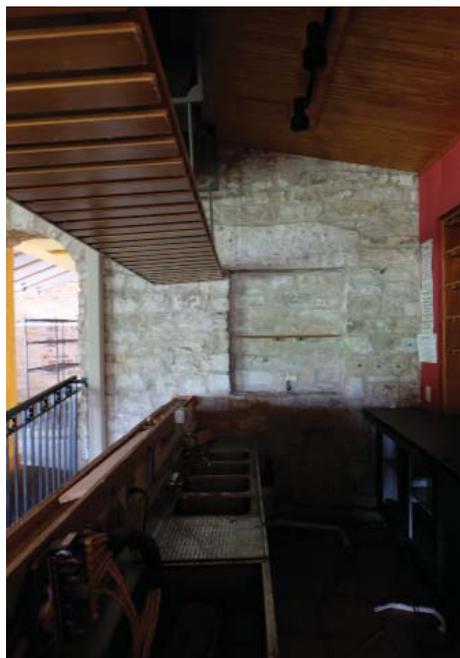
Built-in bar at south side of historic building

The furniture and fixtures are in fair condition.
